## ***Ian T. Cole***

***Professional Registered Soil Scientist / Professional Wetland Scientist***

***RE: Wetland Application, Howard Hale, Construction of Two New Single-Family Homes at 99, 101 & 103 South Beechwood Road, Assessors Map 07.14, Lots 43, 42 and 41, Niantic, Connecticut.***

### **Proposed Activities**

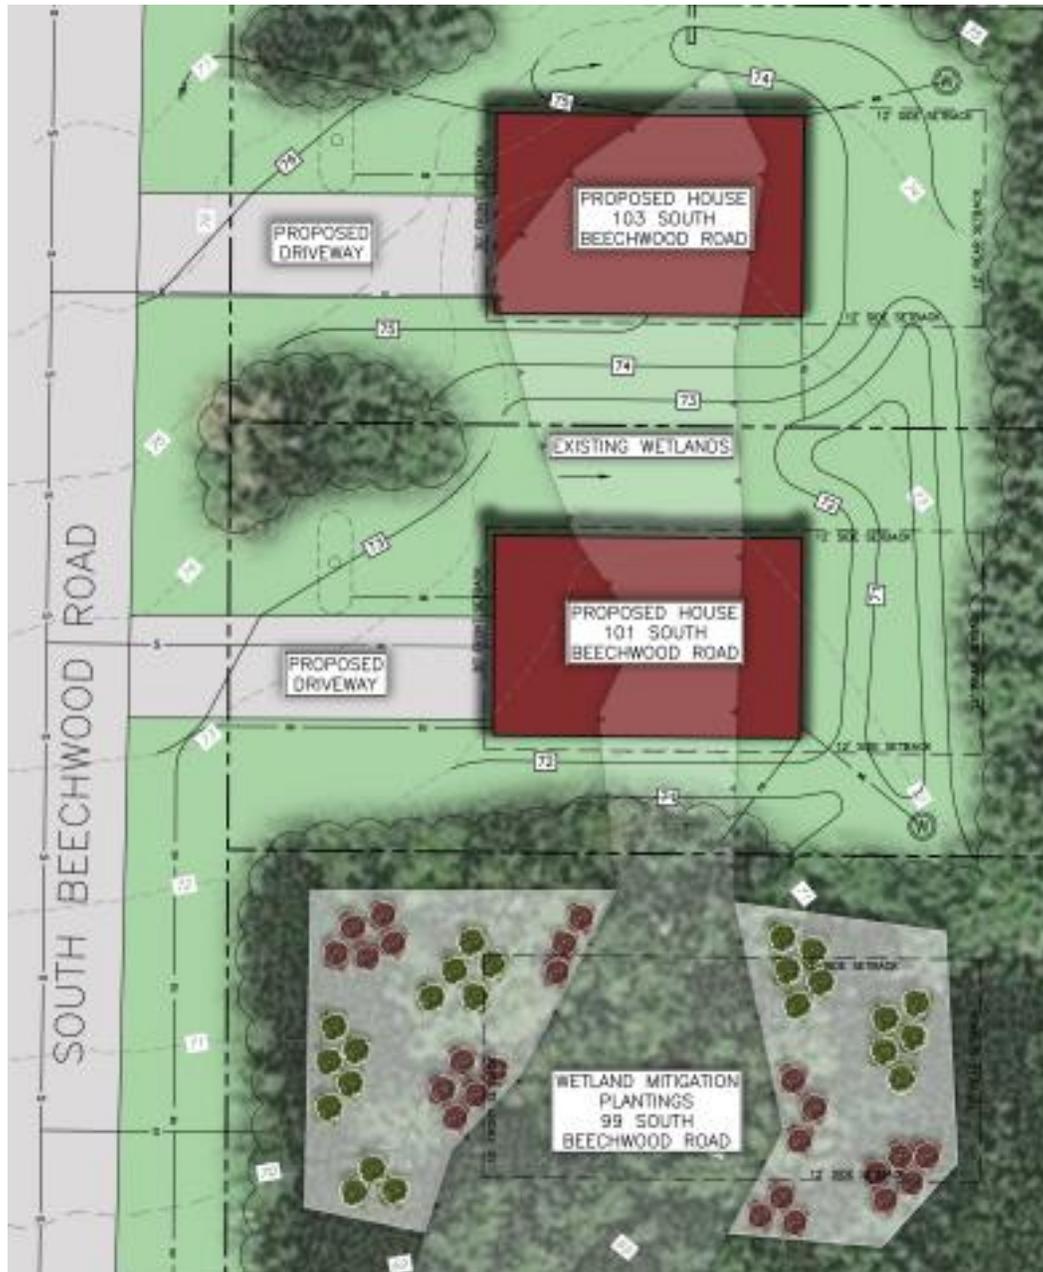
Figure 1: Proposed Development Graphic

The applicant is seeking permission from the Town of East Lyme to develop three lots of record with a total area of 14,961 SF± (0.34 acres) located at 99, 101 and 103 South Beechwood Road in East Lyme, Connecticut. The proposed work will disturb approximately 8,350 SF± (0.19 acre) of land on the combined parcels. The proposed development will include construction of two small (840 SF footprint) new single-family homes on lots 101 & 103 with associated paved driveways, subsurface utilities (municipal water and sewer connections), and landscaping. The project also includes drainage improvements, wetland mitigation and combination of two lots.

The development will require the permanent fill of 1,780 SF of a wetland that bisects the middle portion of the three lots. To mitigate this impact the proposal includes 1,792 SF of plantings and enhancements located on lot 99 which will remain undeveloped. A formal stormwater management system has been professionally engineered by Design

Professionals, Inc, to ensure stormwater leaving the site will not pose any detrimental impacts to the receiving environment. See Figure 1 and for more details; refer to the site plan drawings, entitled "99, 101 & 103 South Beechwood Road, Site Plan Application, East Lyme, Connecticut, prepared by Design Professionals, Inc, dated 7/6/2021, as amended, for information regarding the proposed property development.

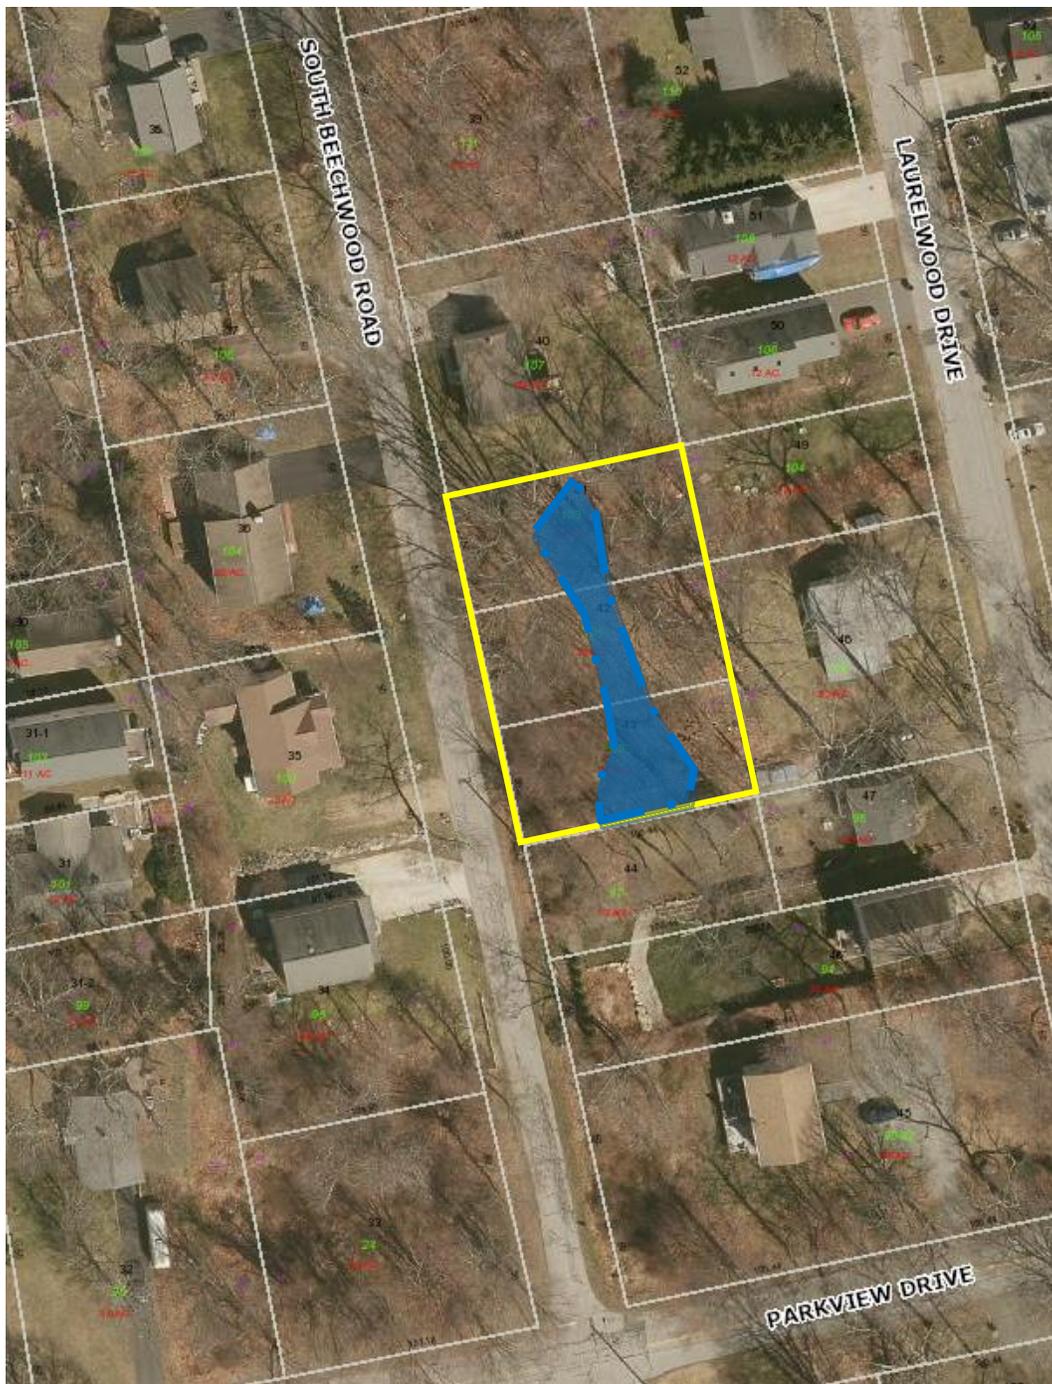
Figure 2: Existing Conditions

As detailed in my April 2015 wetland delineation report provided as part of this 2021 wetland application, there is a small remnant forested wetland that bisects the central portion of the three properties. This remnant wetland is embedded in a moderate to high-density single-family neighborhood. The property is relatively level and drains in a north to south direction. The wetland hydrology is exacerbated by the additional discharge from the neighboring property's 8-inch PVC drainpipe. The wetland was created in part by the construction of South Beechwood Road which raised the topographic relief point creating a low spot in the landscape where water collects. While there is no formalized channel / intermittent stream, the wetlands form a subtle low spot in the landscape that conveys overland flow south to downstream receiving wetlands.

At the time of my July 2021 site visit there was continuous flow discharging from the above mentioned 8-inch PVC drainpipe into the wetland, but interestingly there was no standing water or readily observed signs of recent surface flow within the interstitial space between the large surface stones. This observation demonstrates the wide seasonal variability of the wetland as during the dry summer months the wetland is nearly unrecognizable as such to the layperson.

The on-site wetland exhibits classic wooded swamp vegetation with red maple (*Acer rubrum*) dominating the forest overstory, a shrub stratum dominated by spicebush (*Lindera benzoin*), winterberry (*Ilex verticillata*) with patches of multiflora rose (*Rosa multiflora*) and green briar (*Smilax spp*). The wetland soils are classified as poorly drained Ridgebury and Leicester extremely stony fine sandy loam hydric soils.

As with most highly disturbed areas the upland are vegetated by a mixture of invasive and early successional wetland plants. The upland soils are classified belonging to the Sutton moderately well drained fine sandy loam soil series. Encroachments of brush, leaves, and lawn clipping debris of neighboring compost piles are intermittently encountered at the peripheral of the property. Photos of the existing conditions are attached as appendix A.

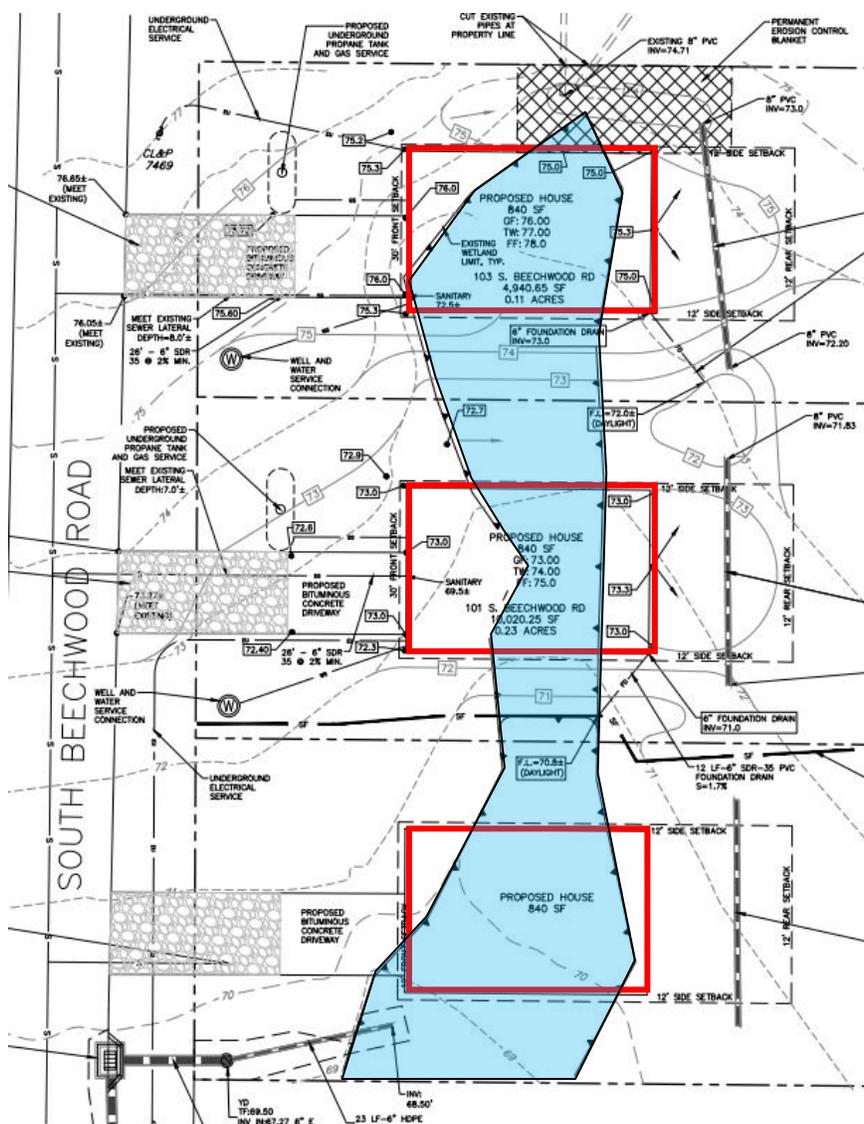
Figure 3: Alternative 3-Lot Build

The alternative concept of a full build out of all three lots of record was considered (see figure 3). A full build out would require nearly completely filling in all the of the wetlands on the project site as well as nearly using nearly all available upland making mitigation potential and water quality renovation features extremely limited. The preferred plan, developing only two of the three lots provides allowances for mitigation and water quality features while still achieving the project needs of the applicant.

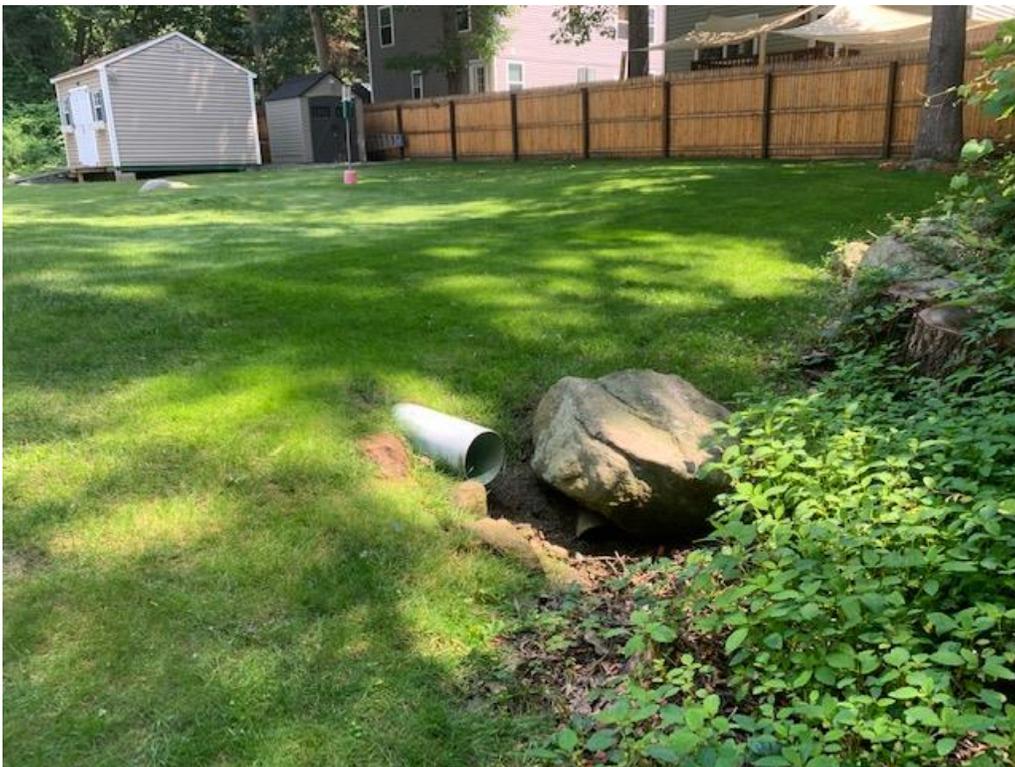
Photo 2: 8" Drainpipe that discharges to wetlands from neighboring property to the north.

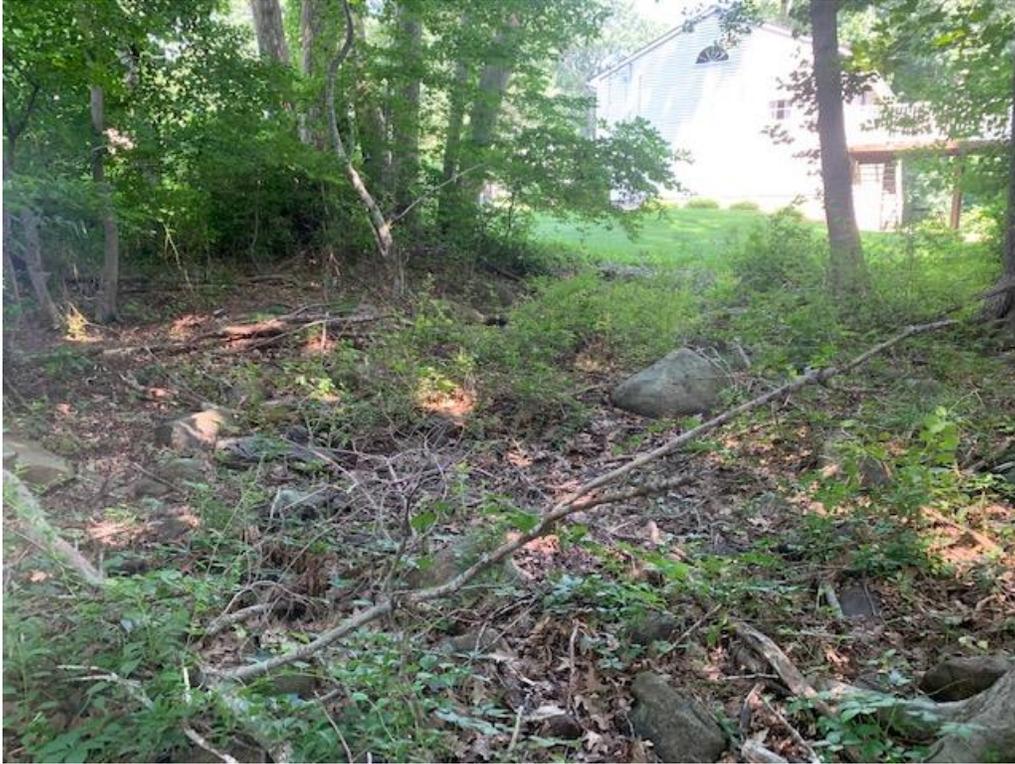
Photo 3: Existing Wetland on Lot 101 & 103, note during dry summer months wetland is nearly unrecognizable as such when hydrology is lacking

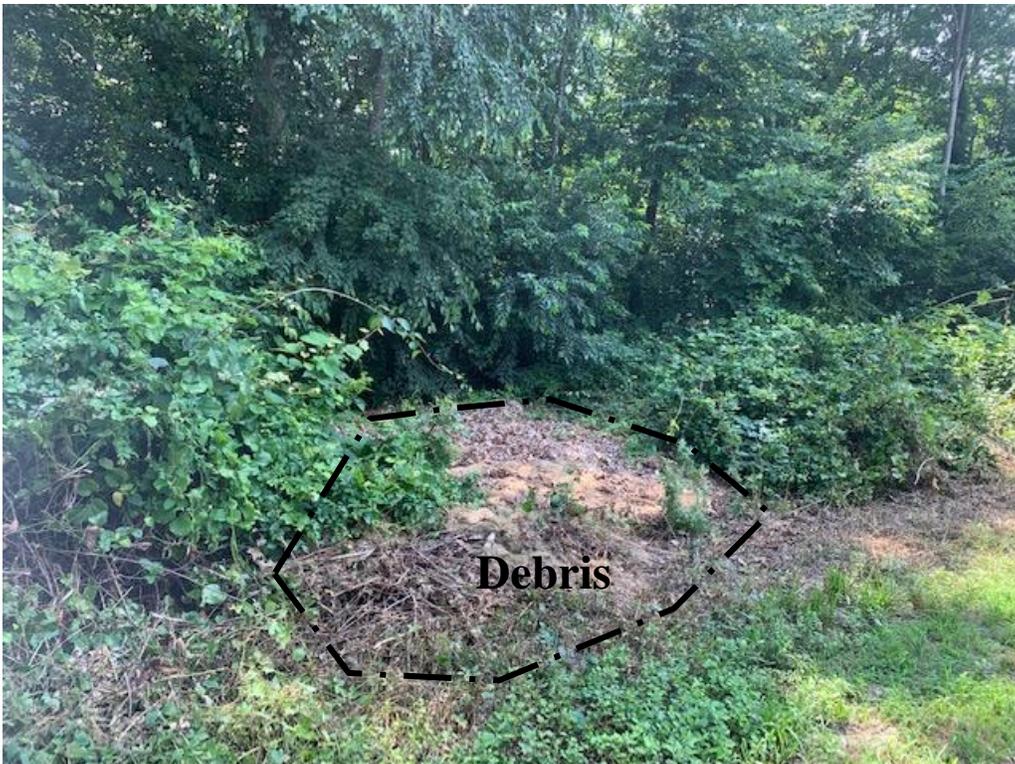
Photo 4: Example of one of the leaf, lawn clippings and brush compost piles that encroach on the property

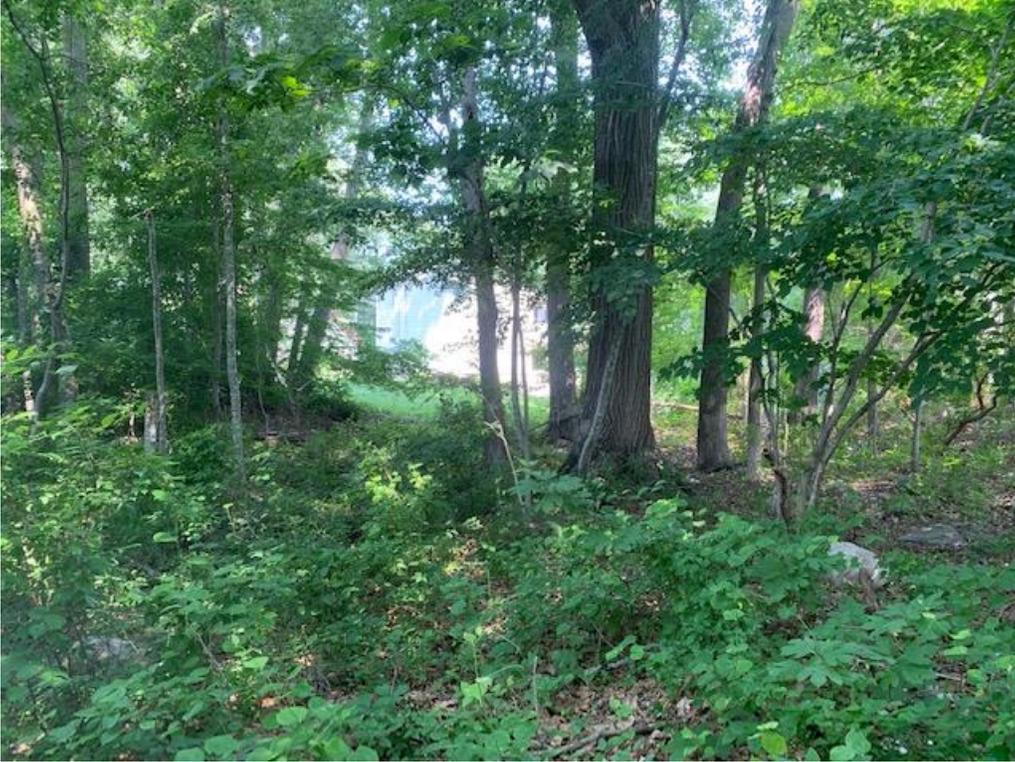
Photo 5: Example of Uplands on property in vicinity of proposed homes
