Property Owner:
 Port Side Holdings Inc.
 English Harbour Capital Partners LLC
 as Tenants in Common

Natural and Cultural Resources and Site Analysis Map
 Holmes & Upper Walnut Hill Road - 5 Lot Subdivision
 Scale = 1"=200"
 Site 12.40 Acres

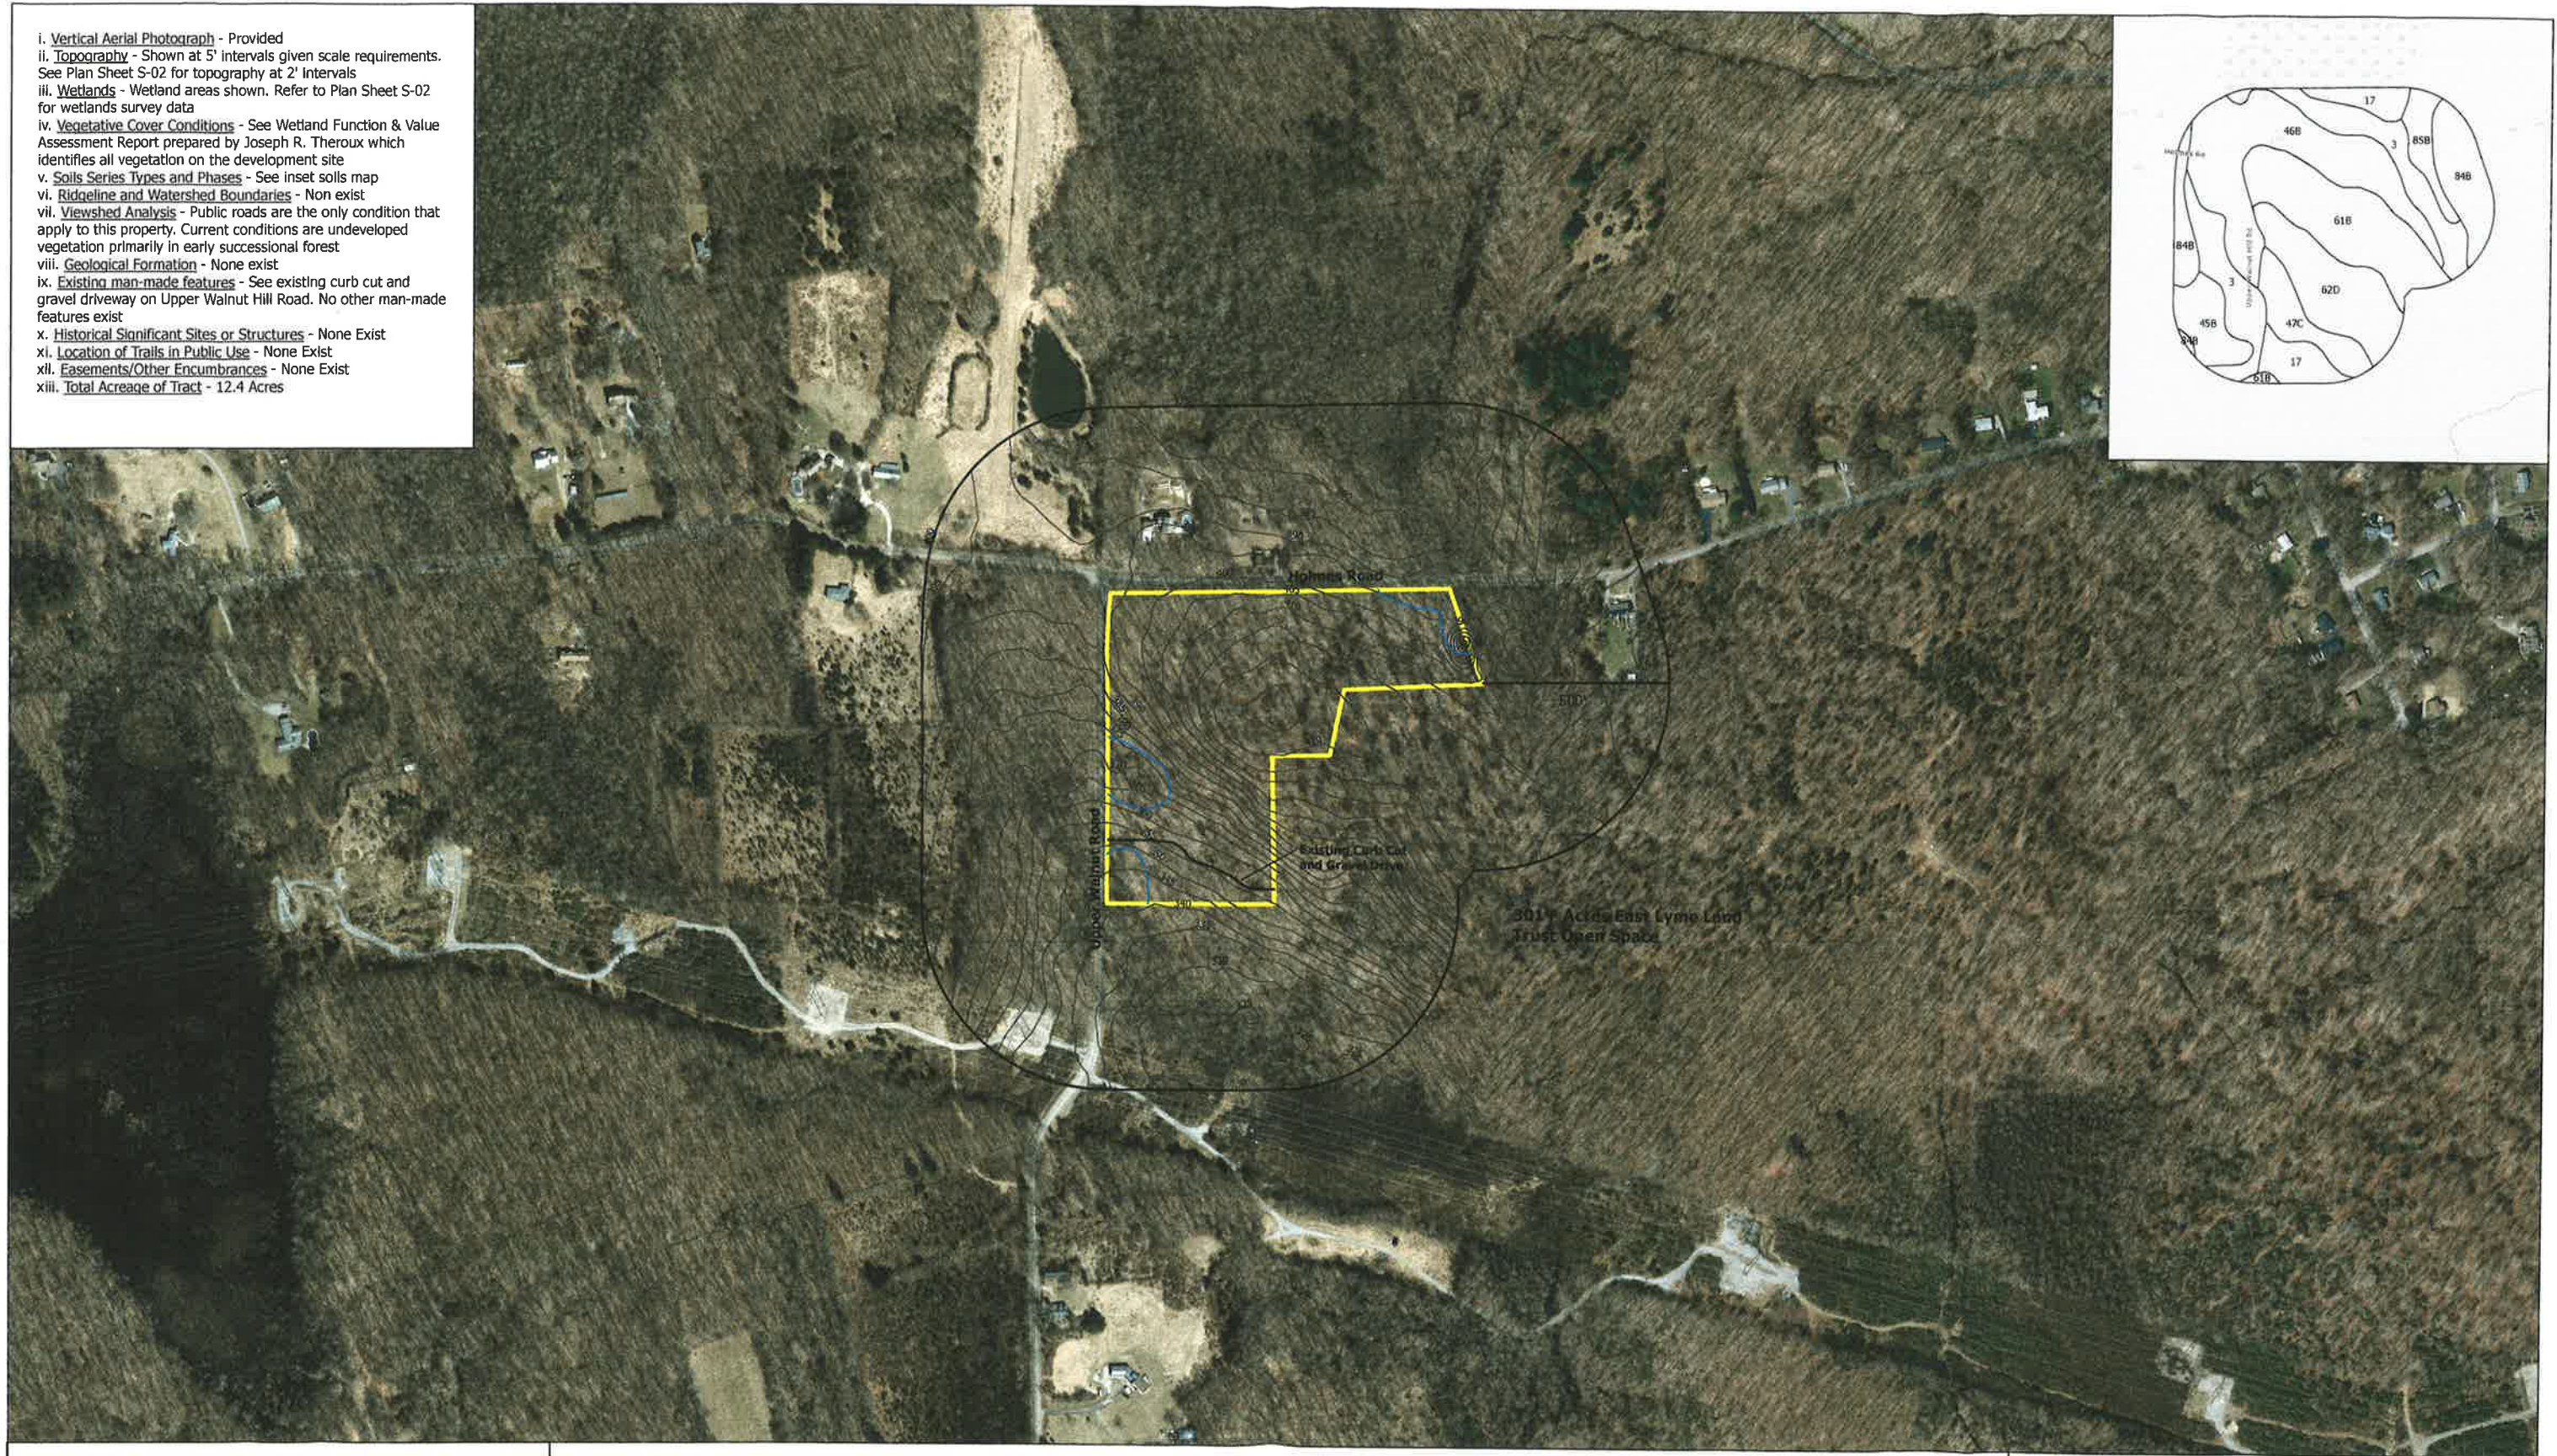
- i. Vertical Aerial Photograph - Provided
- ii. Topography - Shown at 5' intervals given scale requirements. See Plan Sheet S-02 for topography at 2' Intervals

- iii. Wetlands - Wetland areas shown. Refer to Plan Sheet S-02 for wetlands survey data
- iv. Vegetative Cover Conditions - See Wetland Function & Value Assessment Report prepared by Joseph R. Theroux which identifies all vegetation on the development site

- v. Soils Series Types and Phases - See inset soils map
- vi. Ridgeline and Watershed Boundaries - Non exist
- vii. Viewshed Analysis - Public roads are the only condition that apply to this property. Current conditions are undeveloped vegetation primarily in early successional forest

- viii. Geological Formation - None exist
- ix. Existing man-made features - See existing curb cut and gravel driveway on Upper Walnut Hill Road. No other man-made features exist

- x. Historical Significant Sites or Structures - None Exist
- xi. Location of Trails in Public Use - None Exist
- xii. Easements/Other Encumbrances - None Exist

- xiii. Total Acreage of Tract - 12.4 Acres
