Addendum for Phase Ia/b Archaeological Reconnaissance Survey
For An Additional Lot 4 On Proposed Subdivision At
220 Pennsylvania Ave, East Lyme, CT.

December 2023

Report prepared for:
Petrit Marku
220 Pennsylvania Ave
East Lyme, CT.

Report prepared by:
Sarah Holmes, PhD
Archaeology Consultant
860 501-1446, slh@att.net

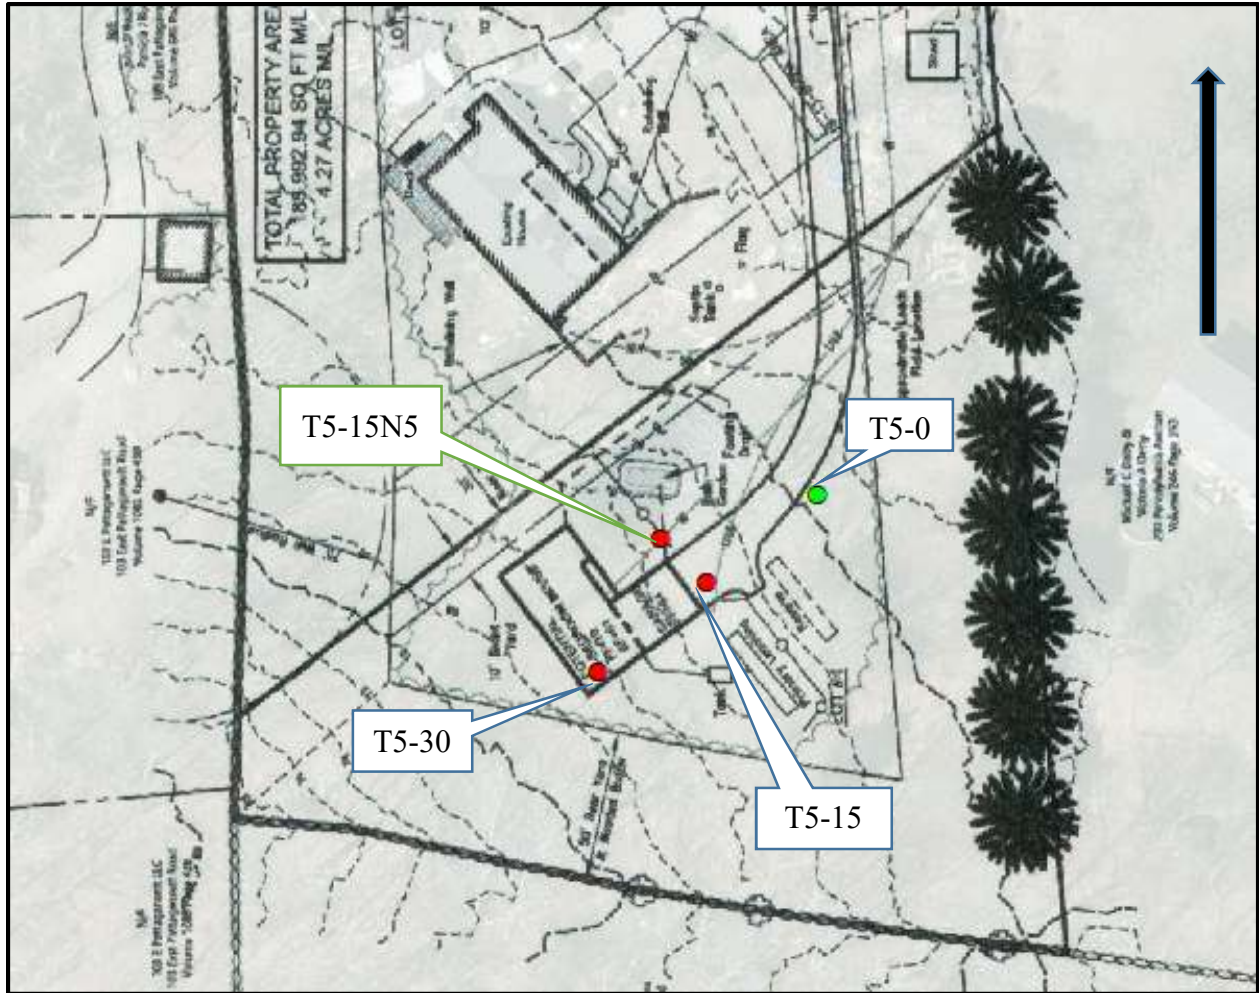
Fig. 1 Map of STP locations on Lot 4. T5-0 yielded four artifacts.

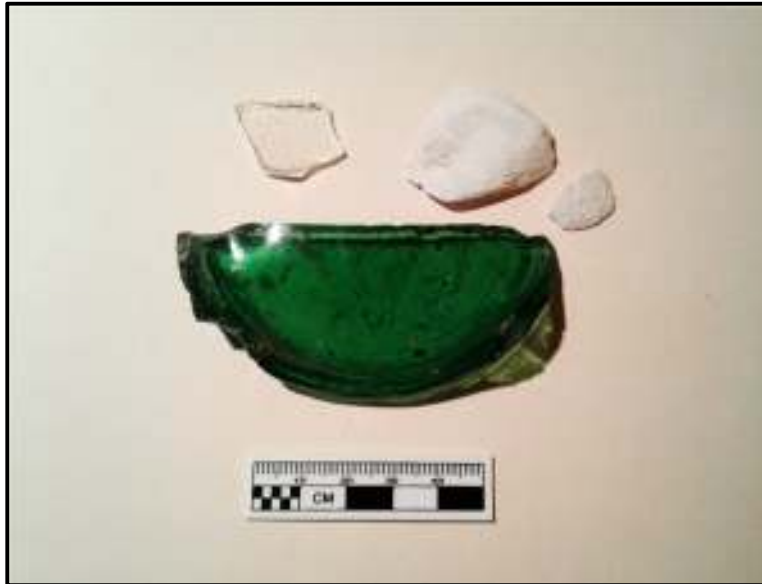
Fig 2 Artifacts from STP T5-0 included green bottle glass base fragment, clear curved glass bottle fragment and two shell retrieved from A horizon at 15-25 cmbs
