Re: *CONCEPTUAL SITE PLAN REVIEW: SUMMARY OF FINDINGS*

25-unit, Age-restricted Residential Development
91 Boston Post Road, East Lyme, Connecticut

REMA Job No.: 24-2709-ELY20

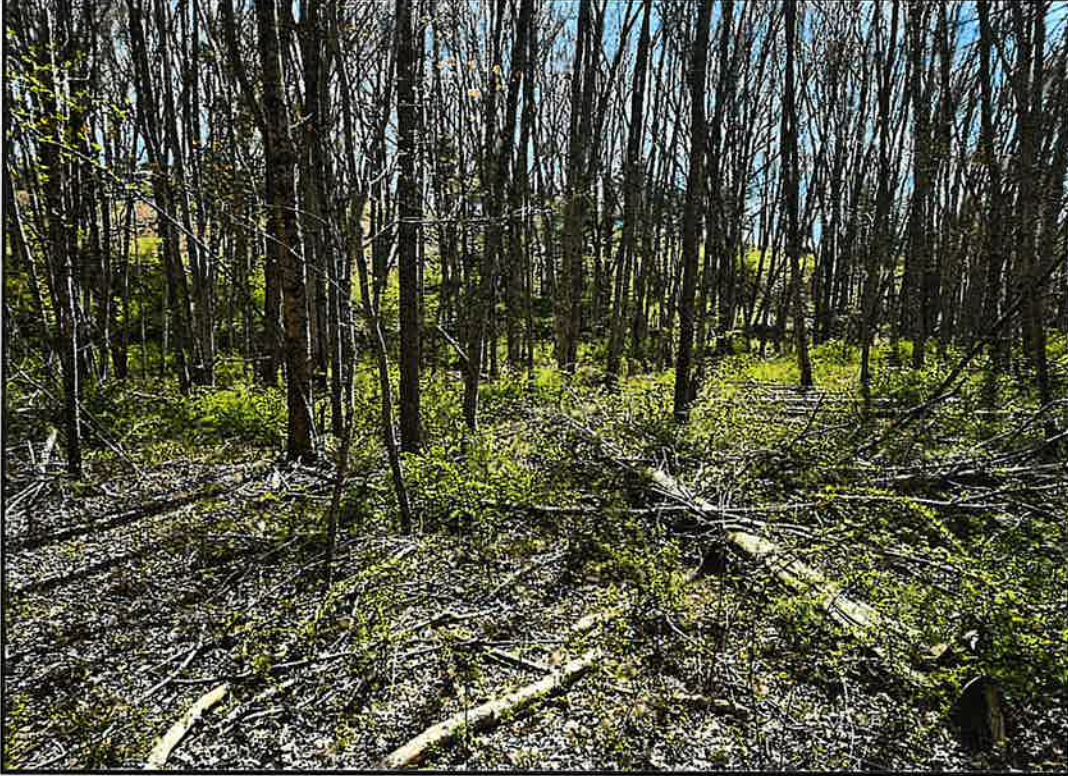
SITE/LOCATION: 91 Boston Post Road East Lyme, CT	REMA JOB NO.: 24-2709-ELY20	ANNOTATED PHOTO LOG
	INVESTIGATOR(S): George T. Logan, MS, PWS, CSE		
DATE: April 27, 2024	FACING: SOUTHERLY	PHOTO NO.: 1

<i>Comments: Moderately well drained uplands easterly of Latimer Brook; post-agricultral red maple dominated forest; not Japanese barberry infestation</i>

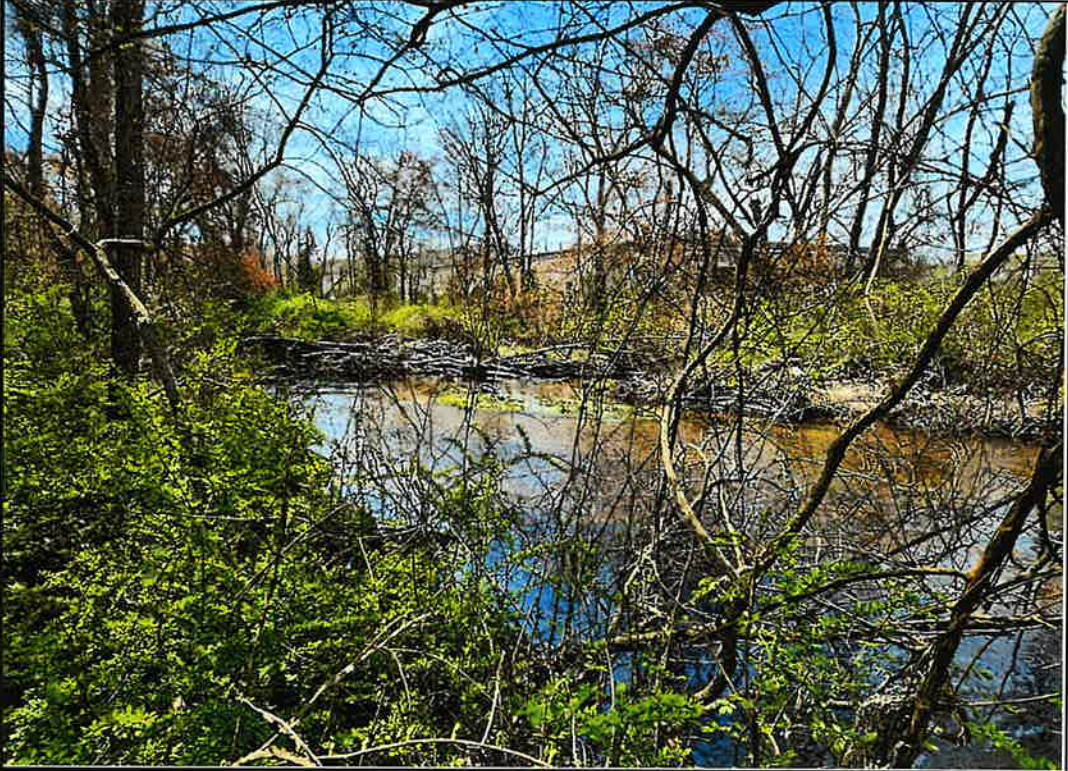
DATE: April 27, 2024	FACING: SOUTHWESTERLY	PHOTO NO.: 2

<i>Comments: View of Latimer Brook from the east bank; note commercial center in background</i>

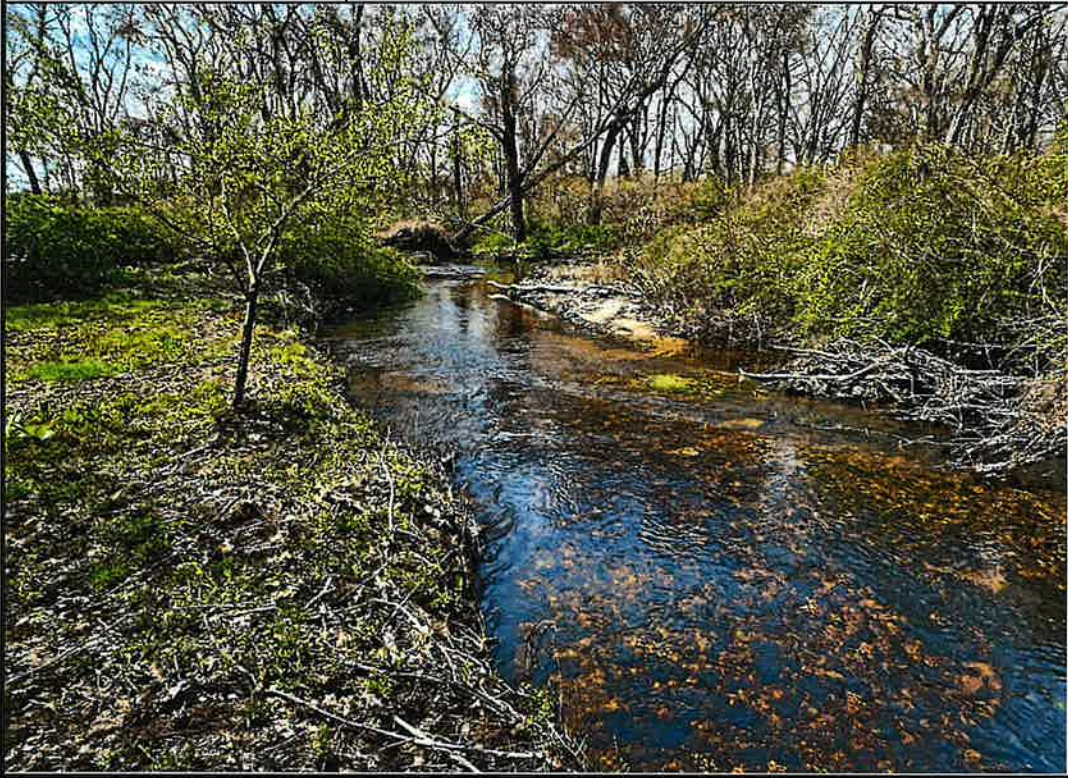
SITE/LOCATION: 91 Boston Post Road East Lyme, CT	REMA JOB NO.: 24-2709-ELY20	ANNOTATED PHOTO LOG
	INVESTIGATOR(S): George T. Logan, MS, PWS, CSE		
DATE: April 27, 2024	FACING: SOUTHWESTERLY	PHOTO NO.: 3

<i>Comments: Latimer Brook as seen from eastern bank, just off-site to the north</i>

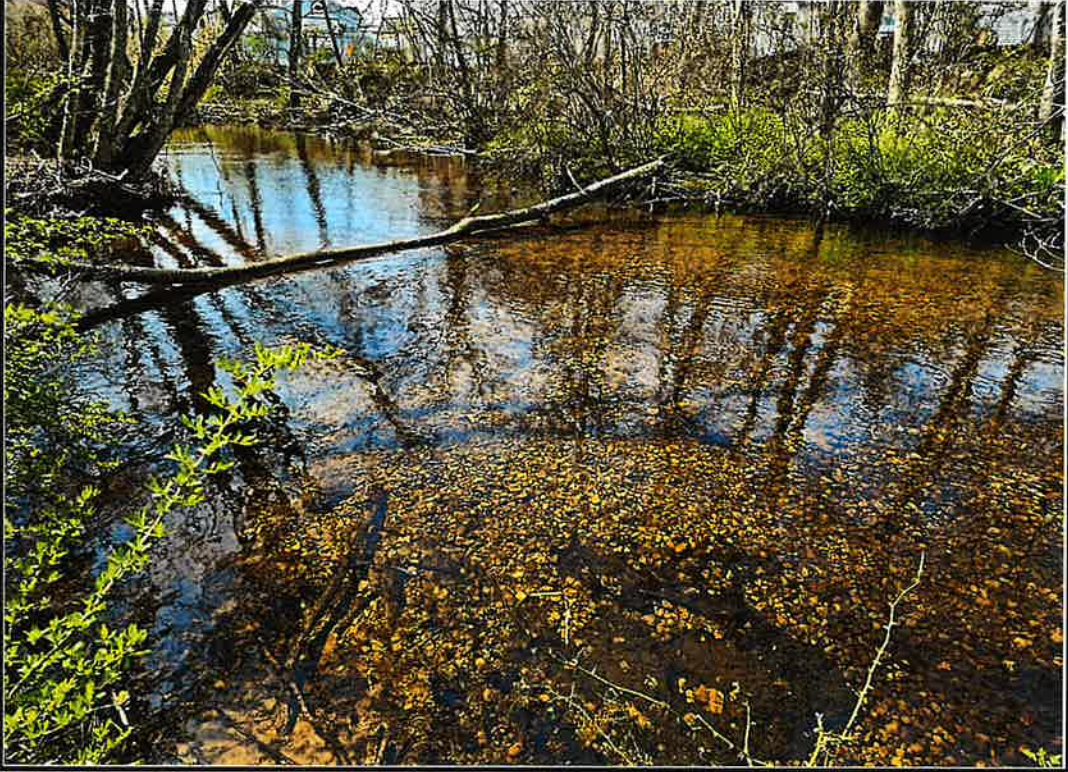
DATE: April 27, 2024	FACING: SOUTHWESTERLY	PHOTO NO.: 4

<i>Comments: Close-up of Latimer Brook in-stream substrate (gravel and stone)</i>

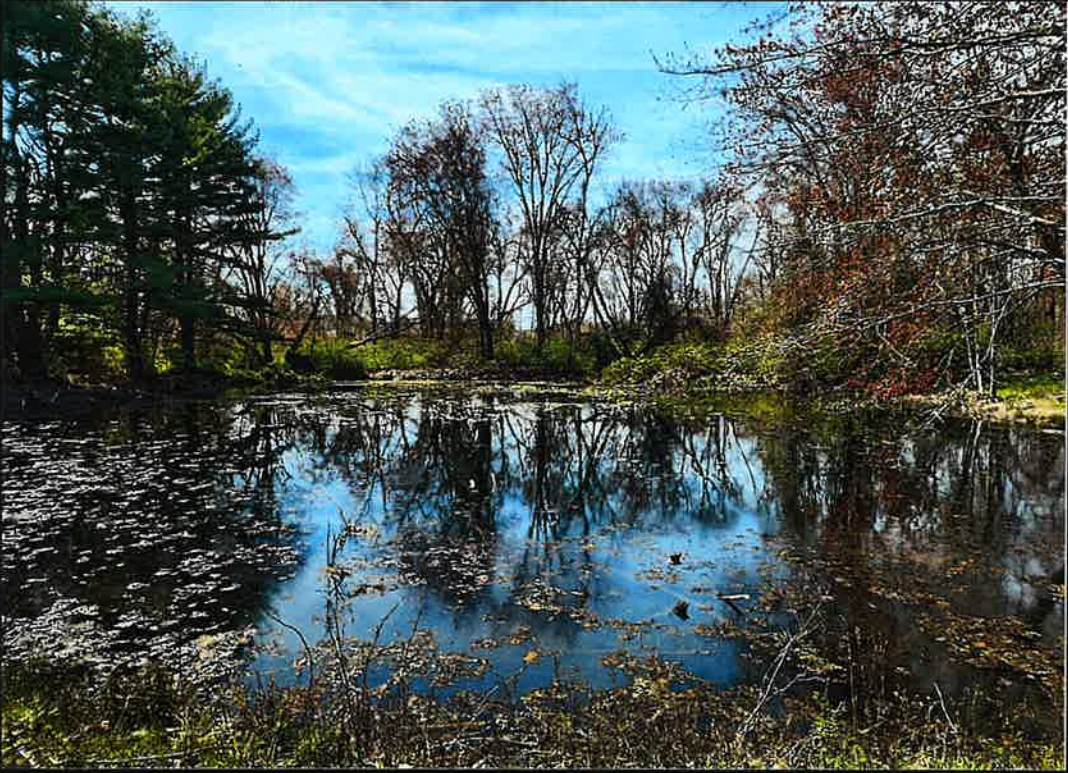
DATE: April 27, 2024	FACING: SOUTHWESTERLY	PHOTO NO.: 6

<i>Comments: Dug-out shallow pond within northwestern section of site</i>

4. A roughly 0.45 acre, shallow dugout pond, is located in the northwestern section of the subject site, 25 to 30 feet easterly of Latimer Brook.
5. Forested wetlands are associated with the Latimer Brook riparian area. These are somewhat extensive within the southwestern section of the subject site.

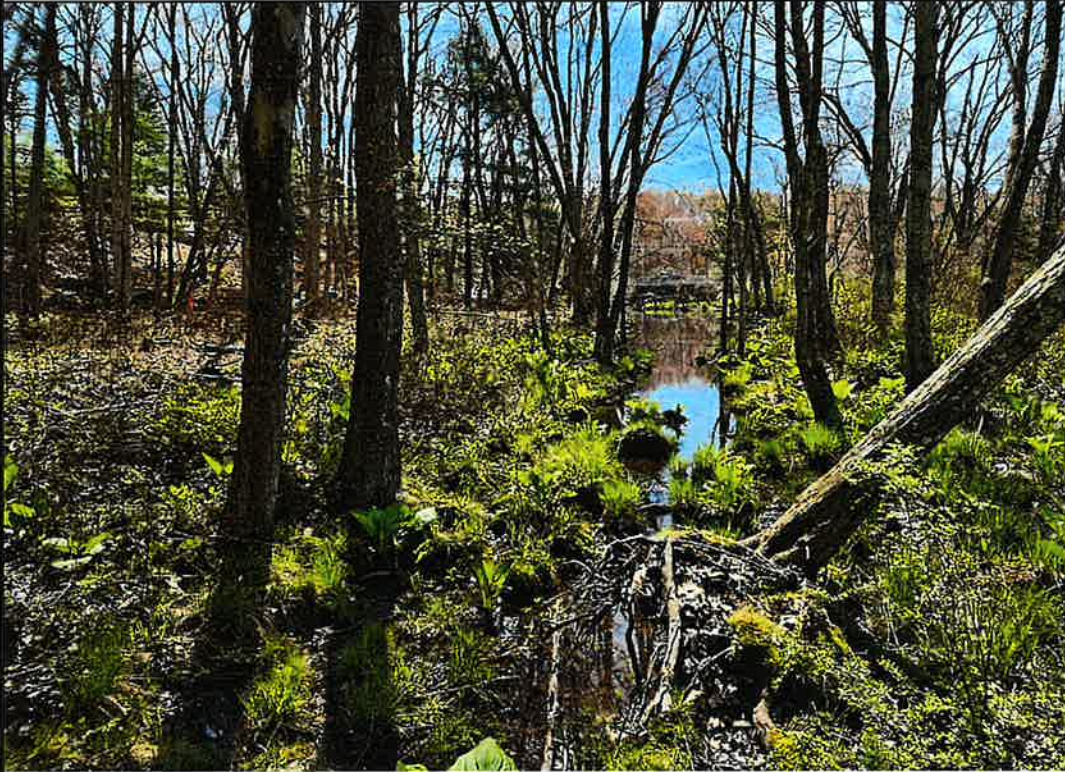
SITE/LOCATION: 91 Boston Post Road East Lyme, CT	REMA JOB NO.: 24-2709-ELY20	ANNOTATED PHOTO LOG
	INVESTIGATOR(S): George T. Logan, MS, PWS, CSE		
DATE: April 27, 2024	FACING: SOUTHERLY	PHOTO NO.: 7

<i>Comments: Flooplain forested wetland associated with Latimer Brook; note box culverts under Boston Post Road in the far background</i>

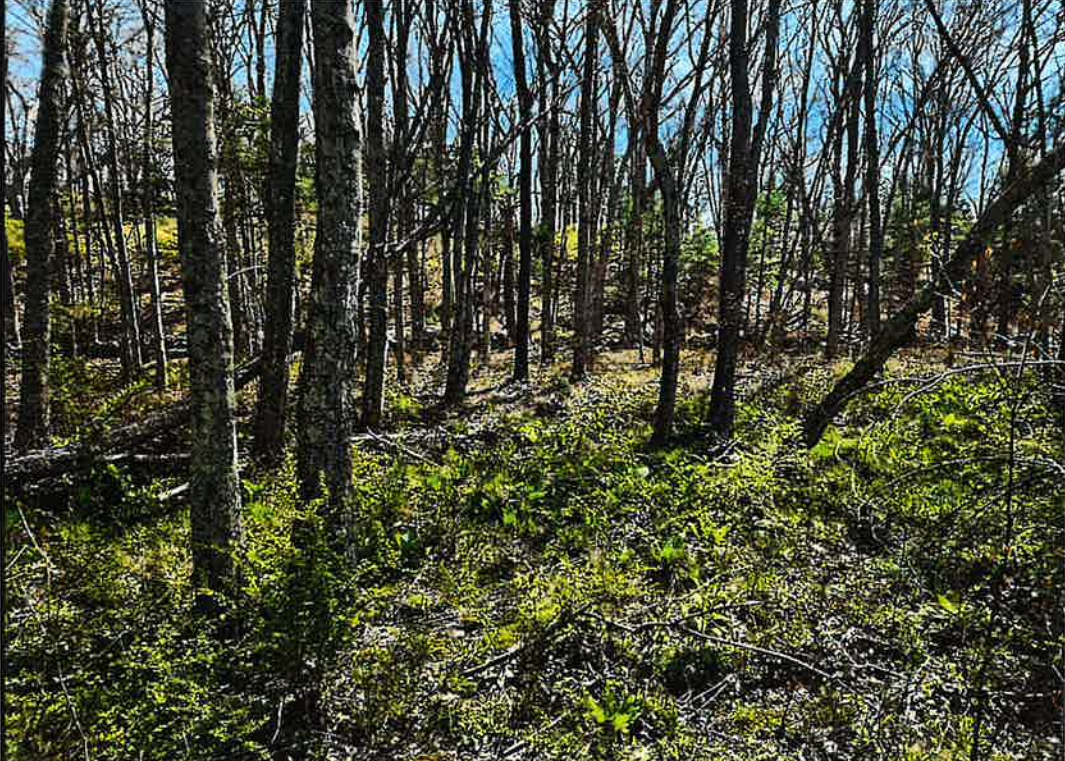
DATE: April 27, 2024	FACING: EASTERLY	PHOTO NO.: 8

<i>Comments: Forested riparian wetland; note rubble wall and slope in background</i>

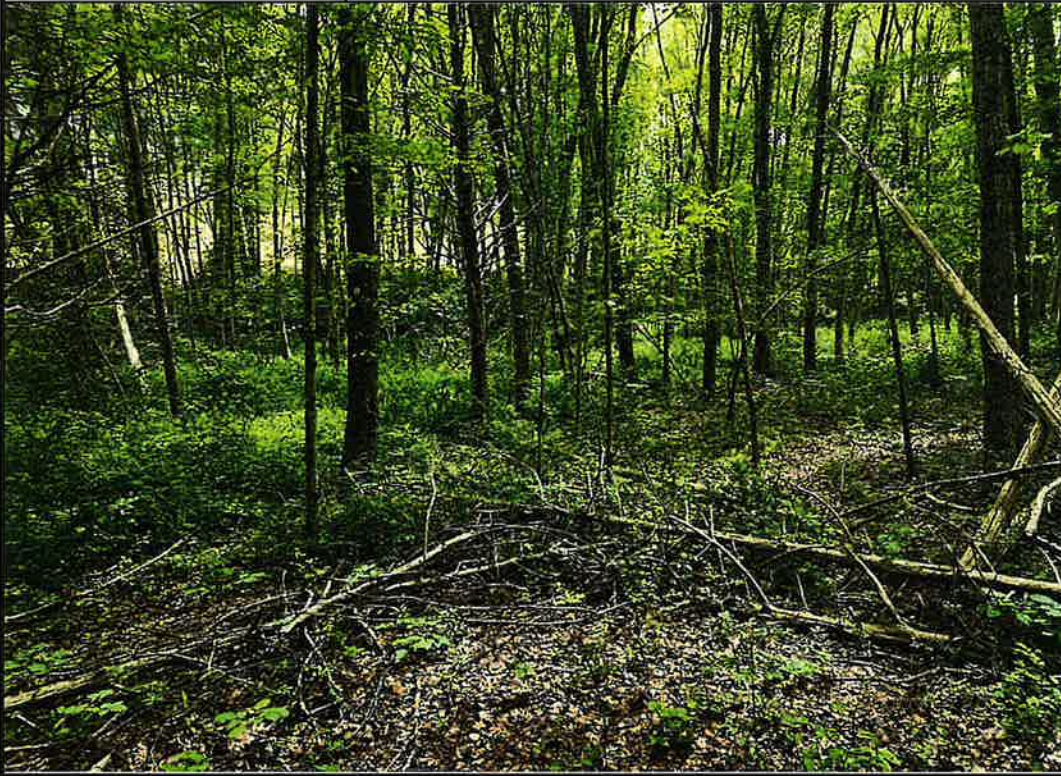
PHOTO NO.: 9

Comments: Floodplain forested upland associated with Latimer Brook 100-year floodplain

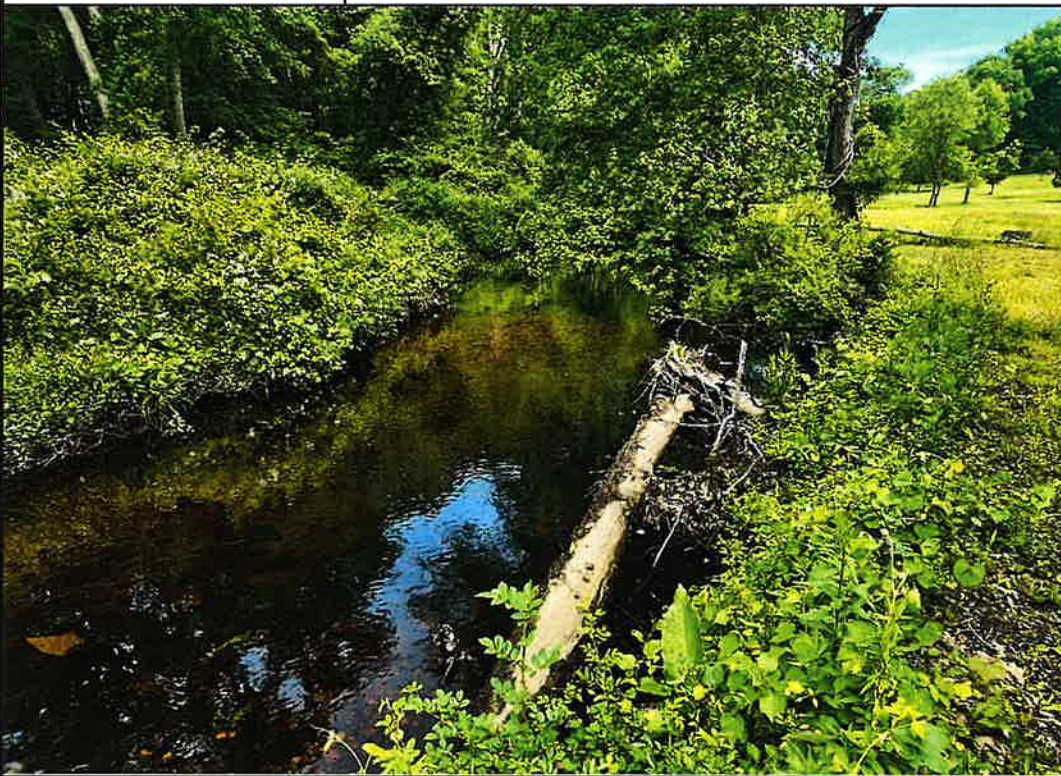
PHOTO NO.: 10

Comments: Latimer Brook; upstream view

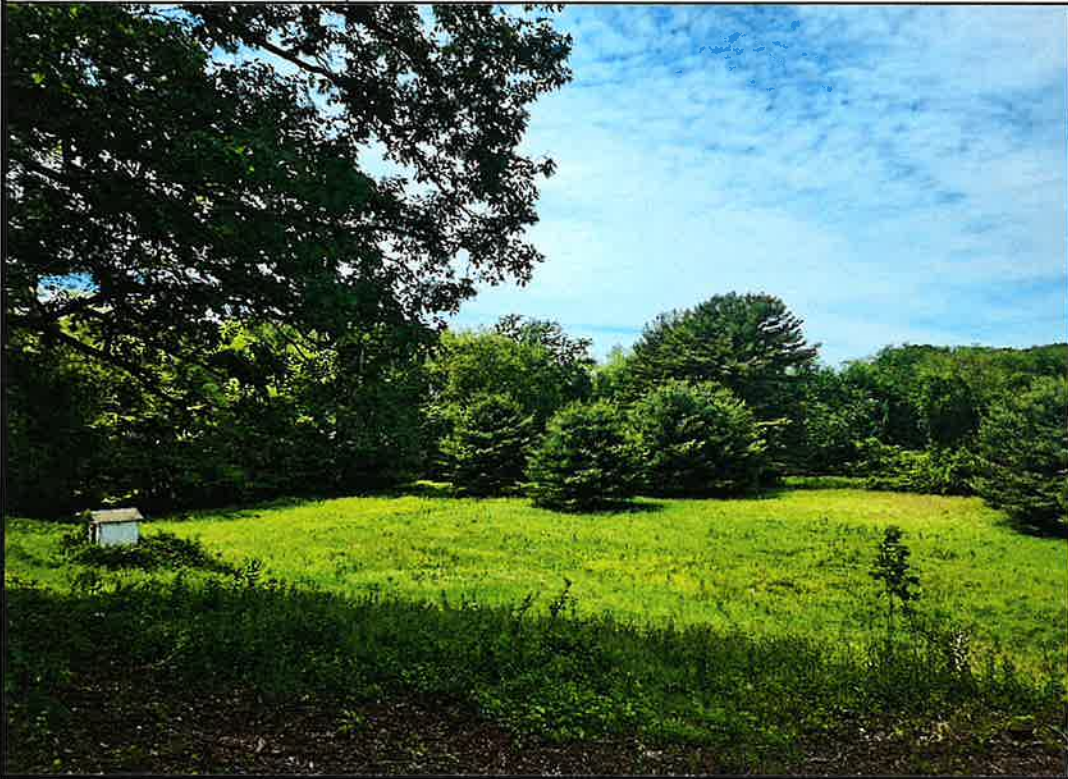
SITE/LOCATION: 91 Boston Post Road East Lyme, CT	REMA JOB NO.: 24-2709-ELY20	ANNOTATED PHOTO LOG
	INVESTIGATOR(S): George T. Logan, MS, PWS, CSE		
DATE: June 3, 2024	FACING: SOUTHEASTERLY	PHOTO NO.: 11

<i>Comments: Moist meadow below existing house structure</i>

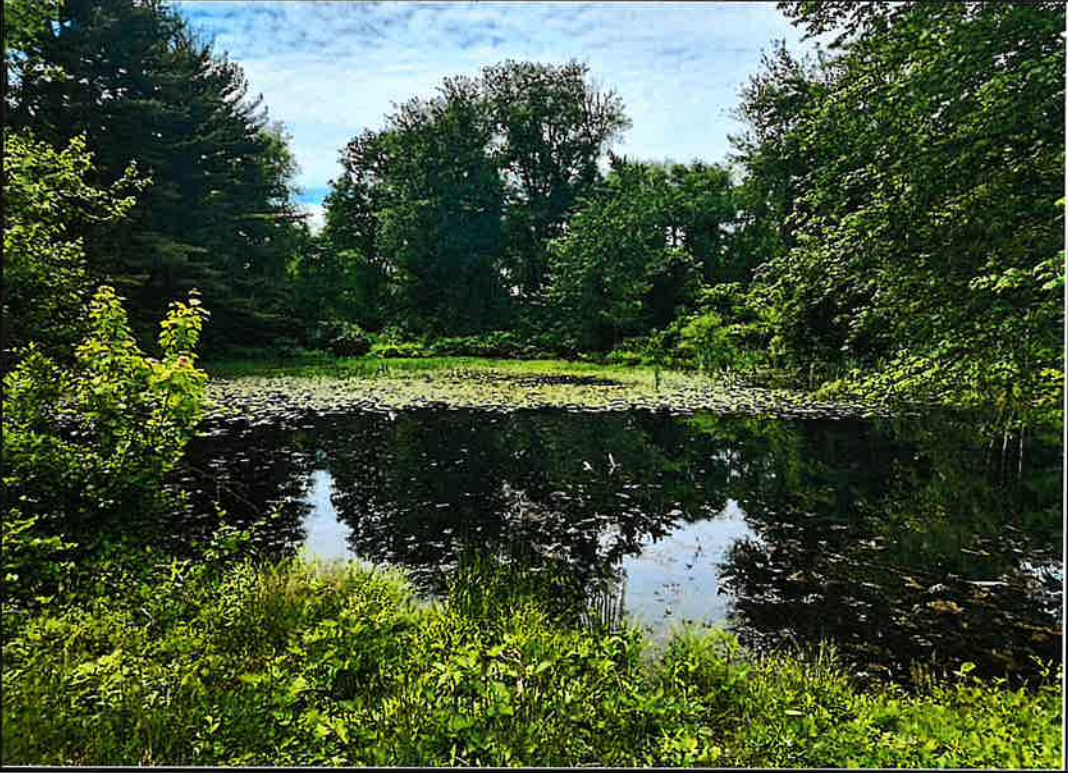
DATE: June 3, 2024	FACING: SOUTHERLY	PHOTO NO.: 12

<i>Comments: Shallow dug-out pond; includes deep marsh habitat</i>

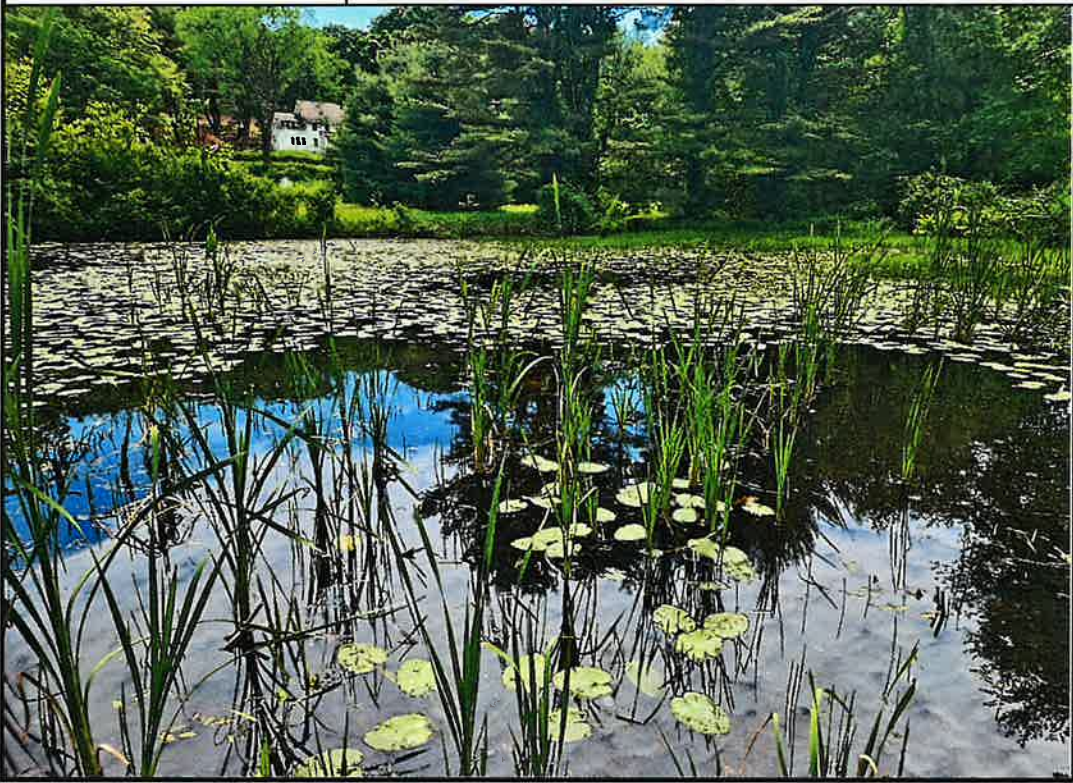
DATE: June 3, 2024	FACING: SOUTHEASTERLY	PHOTO NO.: 13
---------------------------	------------------------------	----------------------

Comments: Close-up of dug-out shallow pond

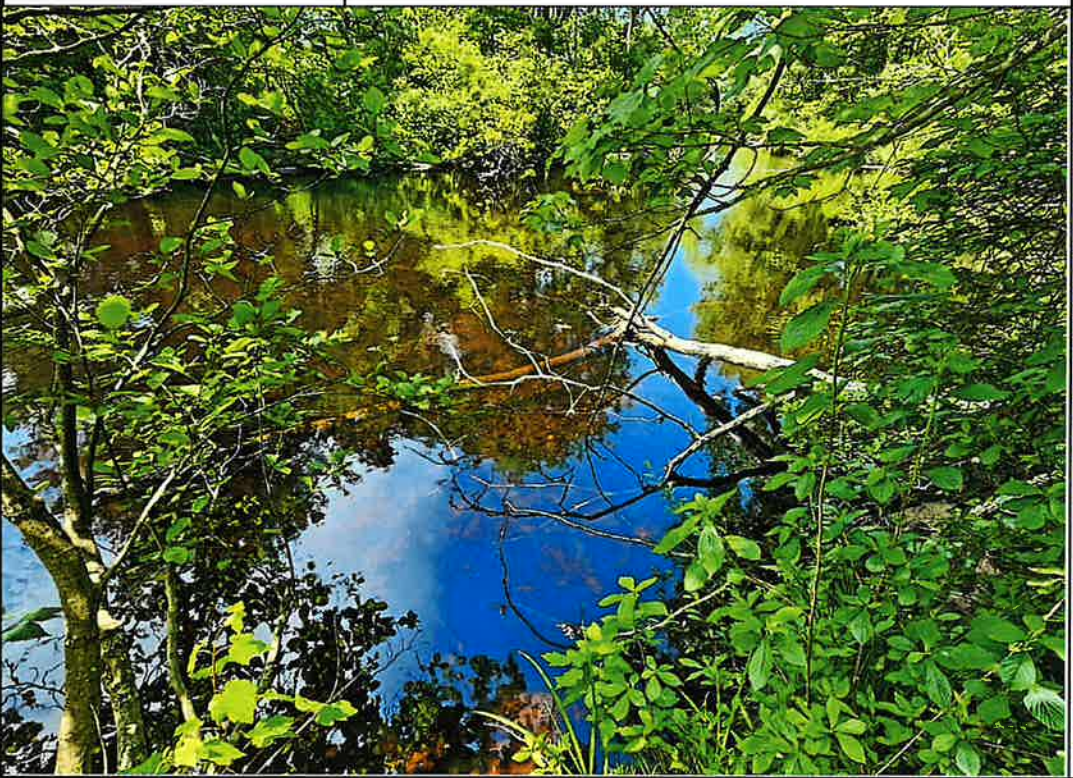
DATE: June 3, 2024	FACING: NORTHERLY	PHOTO NO.: 14
---------------------------	--------------------------	----------------------

Comments: Latimer Brook, just upstream of box culvert under Boston Post Road (upstream view)

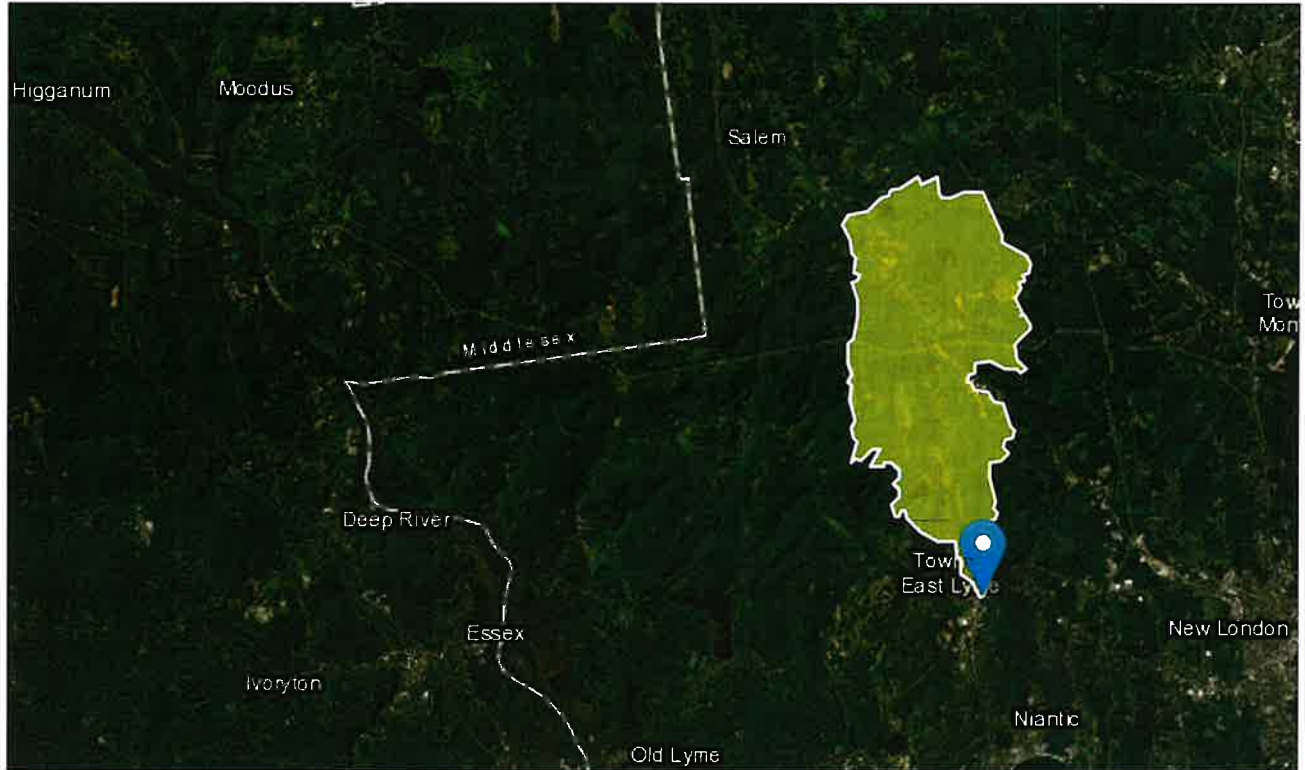
StreamStats Report - Latimer Brook

Parameter Code	Parameter Description	Value	Unit
DRNAREA	Area that drains to a point on a stream	17.2	square miles
LC11DEV	Percentage of developed (urban) land from NLCD 2011 classes 21-24	9.37	percent
LC11IMP	Average percentage of impervious area determined from NLCD 2011 impervious dataset	1.99	percent
MAPM	Mean Annual Precip Basin Average	50.27	inches
