**RE:           WETLAND AND WATERCOURSE DELINEATION REPORT  
              138 NORTH BRIDE BROOK ROAD  
              MBL: 3-1-25  
              EAST LYME, CONNECTICUT**

# WETLAND SURVEY PHOTOS

138 NORTH BRIDE BROOK ROAD

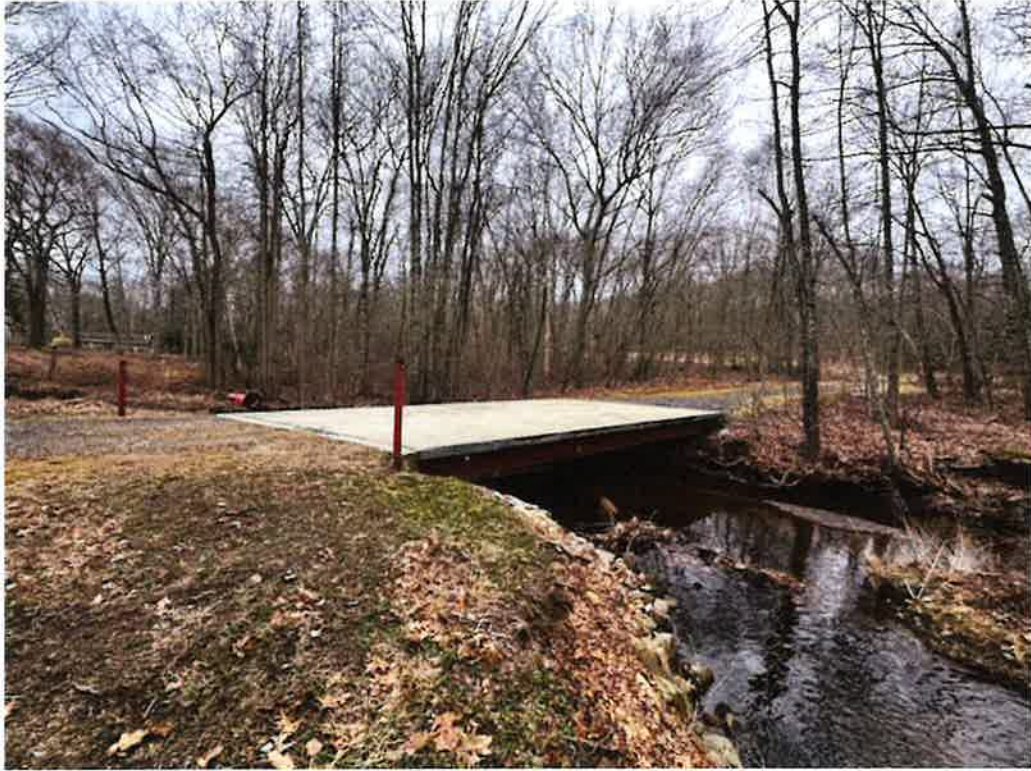
Photo 1: Site access bridge over Bride Brook

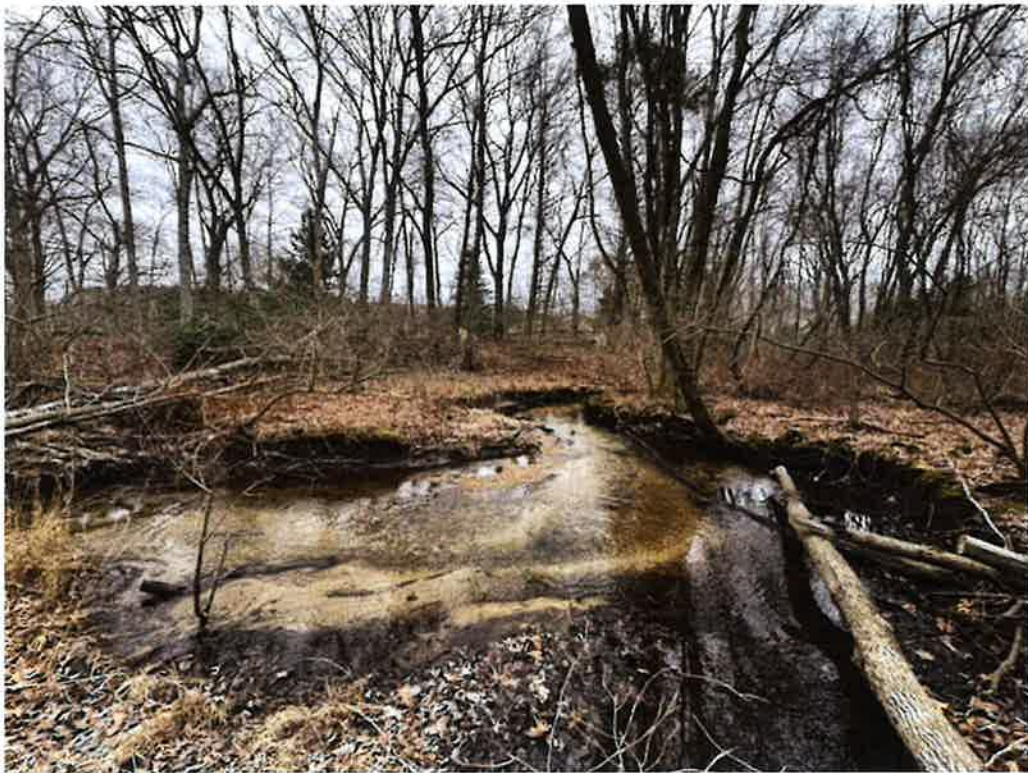
Four (4) wetland areas were identified and flagged on the subject site. The main body of the wetlands is denoted as Wetland # 1 and is delineated by wetland flags 1 through 63. The wetland boundary is found along the well-defined level forested flood plain associated with Bride Brook, which flows south along the east property line. The wetland boundary is very well-defined as the sandy level outwash soils that defines the Bride Brook wetland corridor quickly rise in topography as dense sloping rocky glacial till based soils that characterize the uplands on-site. Wetland #1 is a classic palustrine forested wetland dominated by red maple trees and a shrub stratum comprised of highbush blueberry, winterberry, spicebush and sweet pepperbush.

Photo 2: Example of Wetland #1 & Bride Brook

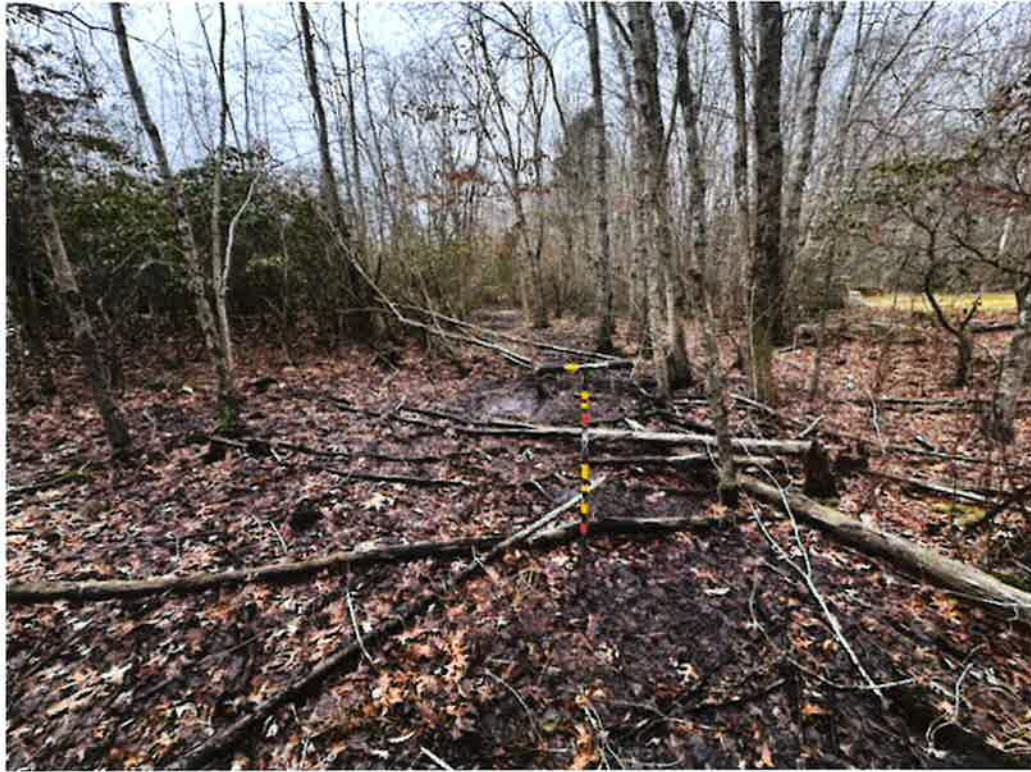
Wetland #2 is an isolated trap-rock wetland pocket. This small narrow, elongated wetland occurs in an area of dense bedrock that captures surface runoff from the rocky landscape above. Because of the underlying bedrock and constricted topographic relief point surface water ponds southeastern corner of the lot creating this small wetland feature. This area quickly dries in the late spring months and is unrecognizable as a wetland throughout most of the year. The wetland lacks any substantial obligate wetland vegetation and the boarding vegetation consists of upland species such as mountain laurel, birch and maple.

Photo 3: Example of Wetland #2

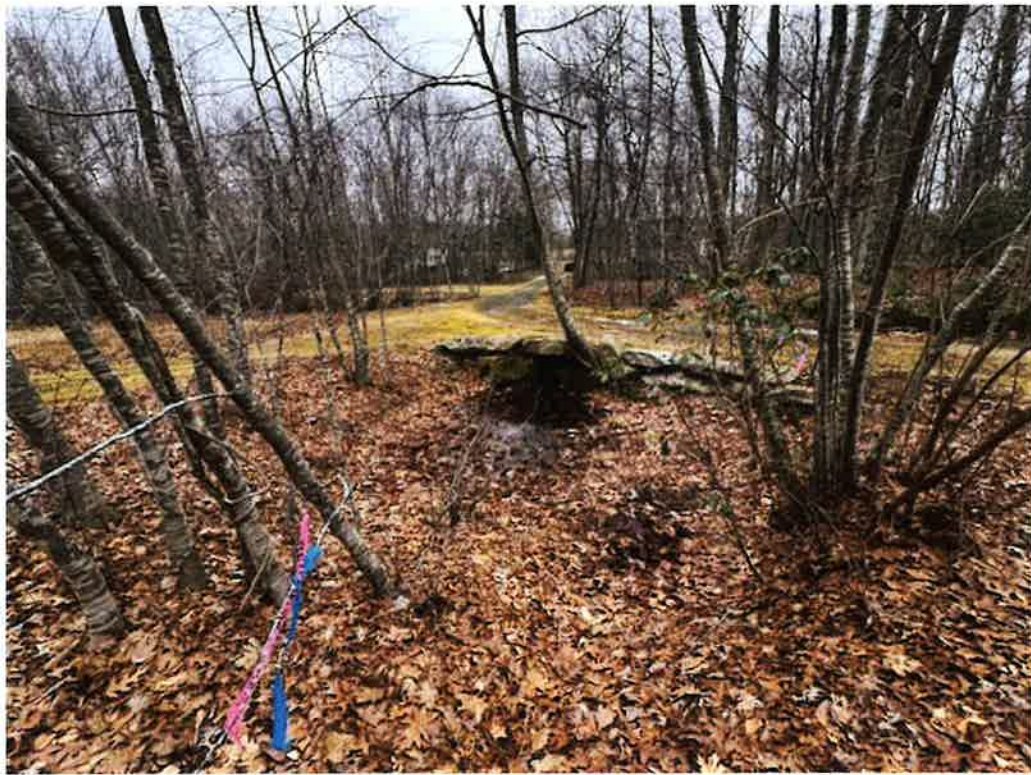
Wetland #3 is a man-made constructed inlet collection point designed to capture overland sheet flow at a topographic low spot. The small man-made pocket wetland drains to a culvert pipe which convey flows easterly under the existing gravel driveway to Bride

Brook. Wetland flags 3-1 to 3-5 mark the wetland boundary and this area of poorly drained soil.

Photo 4: Example of the man-made drainage pocket of Wetland #3.

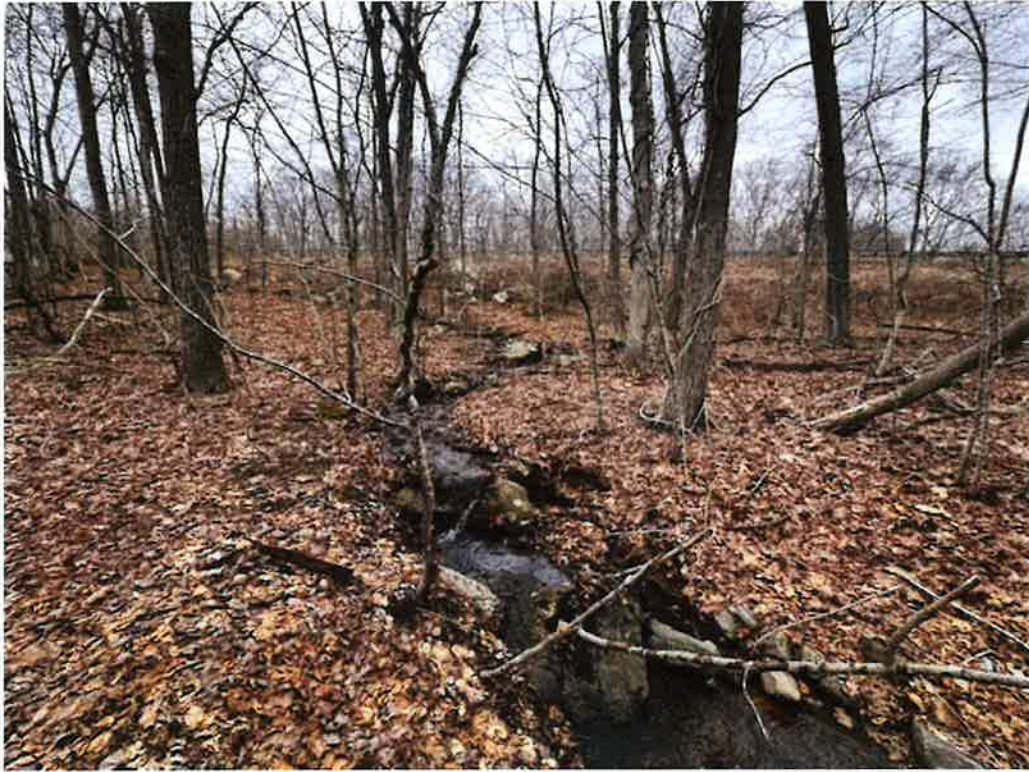
Wetland #4 is channelized drainage that issues onto the property from the highway line and cascades down a steep rocky slope until the terrain levels out dissipating the streams energy into an area of poorly drained soils upgradient of the existing gravel driveway. The wetland and associated watercourse are drained to a culvert which transfers flows under the driveway towards the watercourse's confluence with Bride Brook.

Photo 5: Example of the watercourse that defines Wetland #4

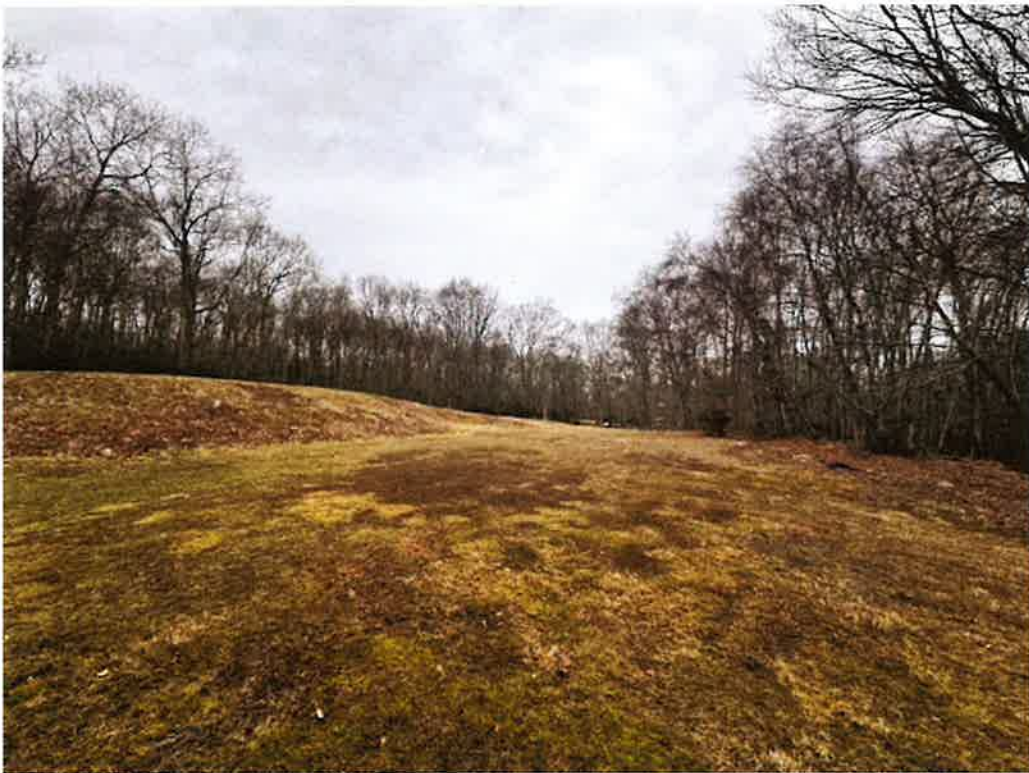
Photo 6 – General site conditions in the middle of the property where previous site work created the park like setting.

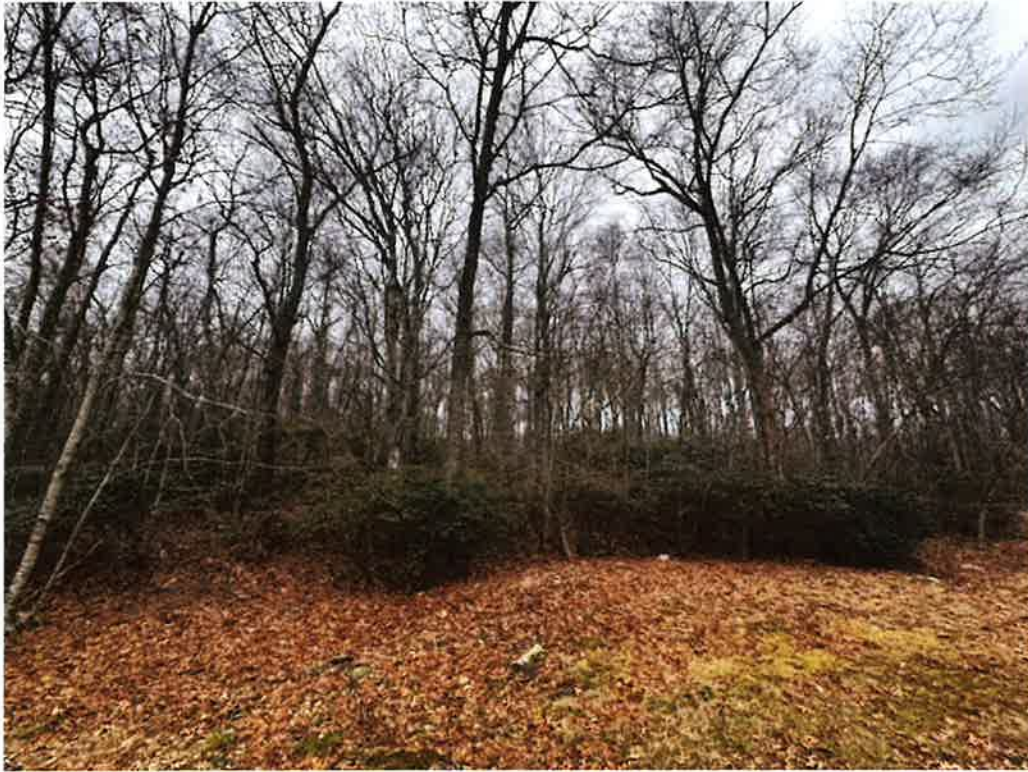
Photo 7: Forested uplands on the site with notable high concentration of mountain laurel shrubs.

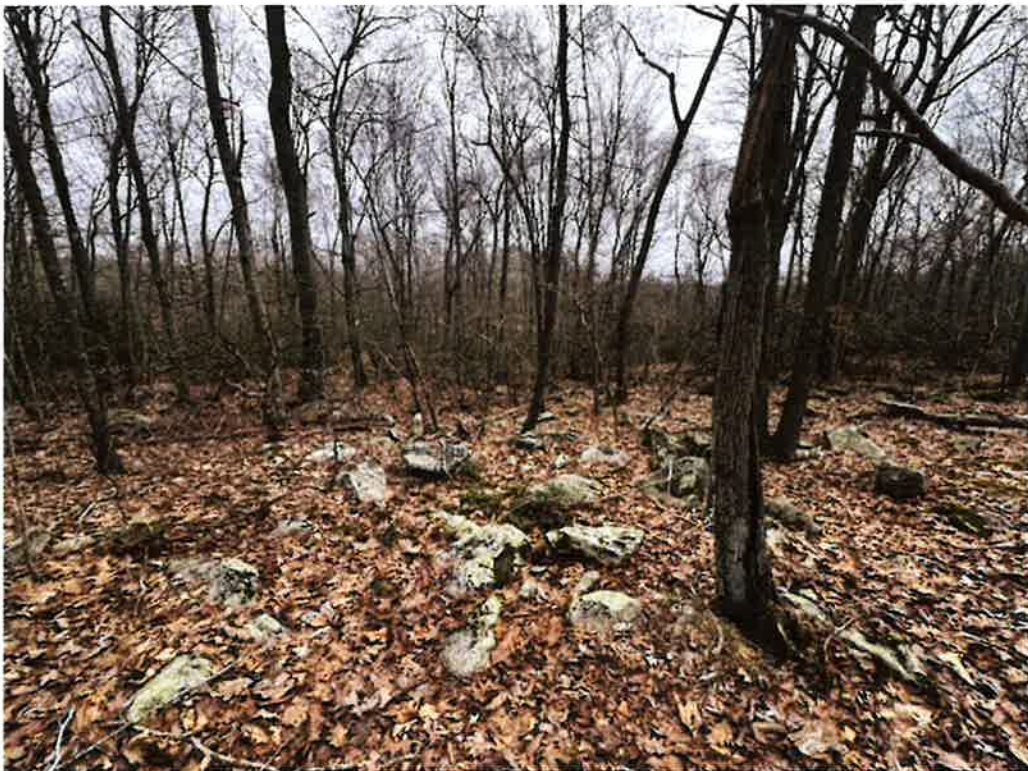
A fifth area previously identified as a wetland circa 2001 and mapped by flags 147-162 and 142-146 as illustrated on the 2001 "Nebelung Farms LLC" Finn Survey. This area was evaluated in March 2025 and after examining the soil conditions, vegetation, hydrology and landscape setting it is my professional opinion this area does not qualify as a wetland or watercourse. The subject area does not qualify as wetland resource or intermittent watercourse because 1. The area/ feature does not host a predominance of hydrophytic vegetation, 2; the area does not contain hydric soils ( Photo 10) 3; the area does not show evidence of persistent flow for longer than a particular storm event (and my site visits came on the heels of the winter thaw and rain events), and 4; the area does not show evidence of channel development or signs of concentrated flow path. The landscape and watershed upgrade of this location has a heavily armored ground structure and occurs in a small boulder field. These hardened ground conditions increase the runoff during storm events creating seasonal seepage which has been accounted for with the small PVC seepage pipes that exchange any seepage collection upgradient of the driveway to the downgradient topographic bowl at the pipes outlet. Photos 8, 9 and 10 illustrate these conditions.

Photo 8: Conditions of area previously flagged as a wetland on 2001 Finn Survey Plan

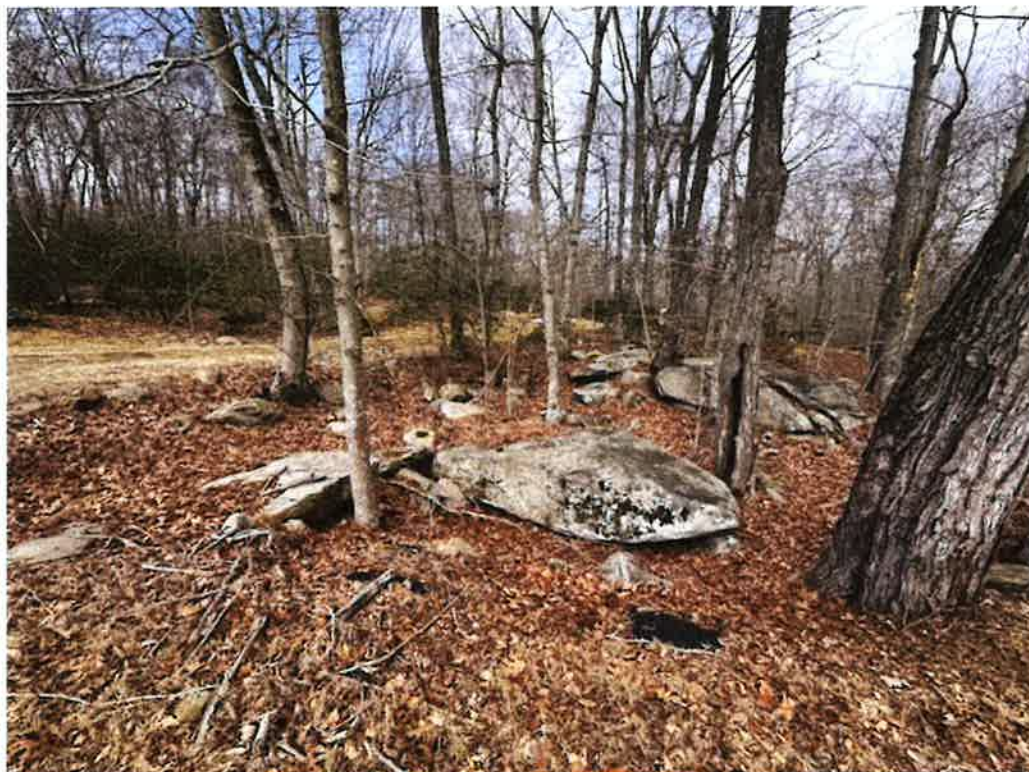
Photo 9: Conditions of the Down gradient portion of the 2001 flagged wetlands shown on the Finn Survey

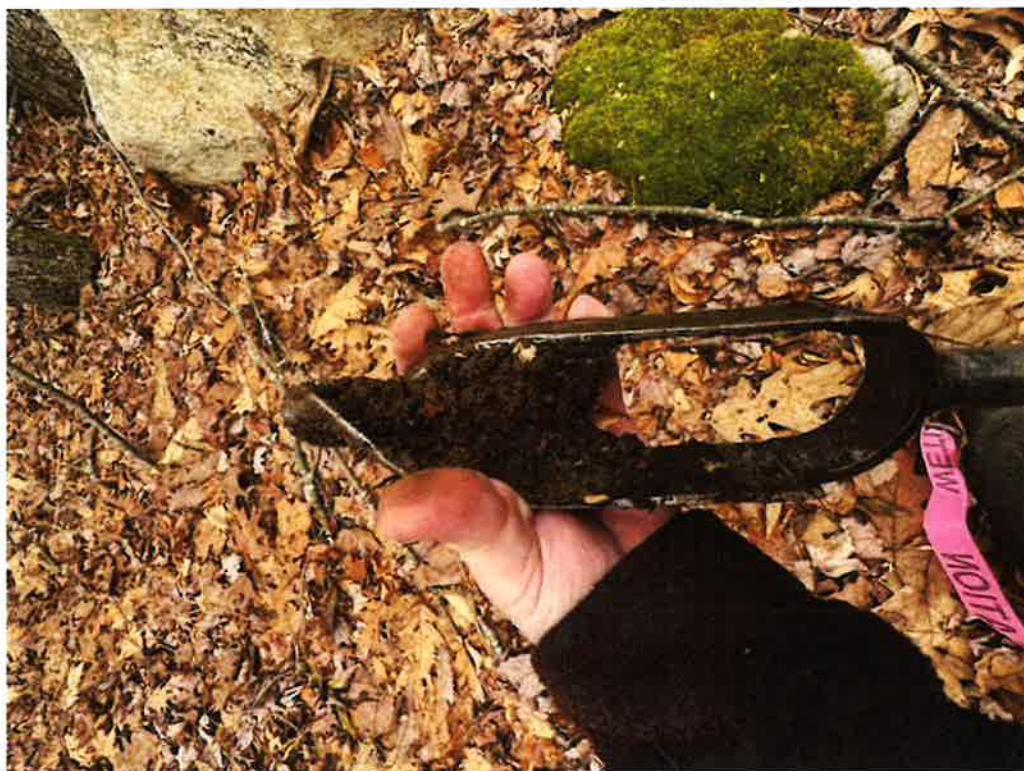
Photo 10: Underlying upland soils in area previously identified as a wetland on 2001 Finn Survey, this soil sample example was taken from the area in Photo #9 above.
