Wetland/Watercourse Delineation Report

Connecticut Federal-Local Bridge Program
Replacement of Bridge 05623 at Colony Road over Latimer
Brook

State Project No. 0044-0161

East Lyme, Connecticut September 2024

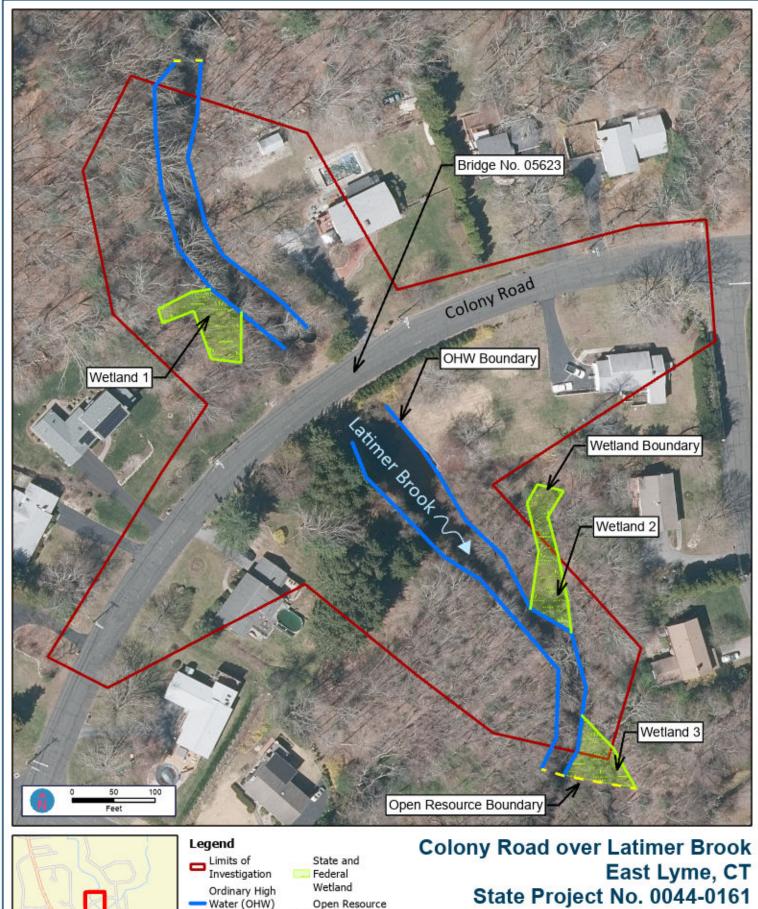
Wetland & Watercourse Delineation Map

State- and federally-regulated wetlands were identified at three locations within the project area and the boundaries of one perennial watercourse, Latimer Brook, were delineated. The OHW Mark associated with Latimer Brook was demarcated in the field. These regulatory resources, delineated in the project area, are depicted on **Figure 2**, **Wetland and Watercourse Delineation Map** in **Appendix A**. The NRCS soils map classifications on, and in the vicinity of, the project area, are depicted by their soil number on **Figure 3**, **NRCS Soils Map** in **Appendix A**. FHI Studio's soil observations conducted during fieldwork support the NRCS mapped designation of Hinckley loamy sand, Pootatuck fine sandy loam, and Canton and Charlton fine sandy loam/soils in and adjacent to the Bridge 05623 project area. In the delineated wetlands, soil was observed to be Rippowam fine sandy loam, 0 to 3 percent slopes.

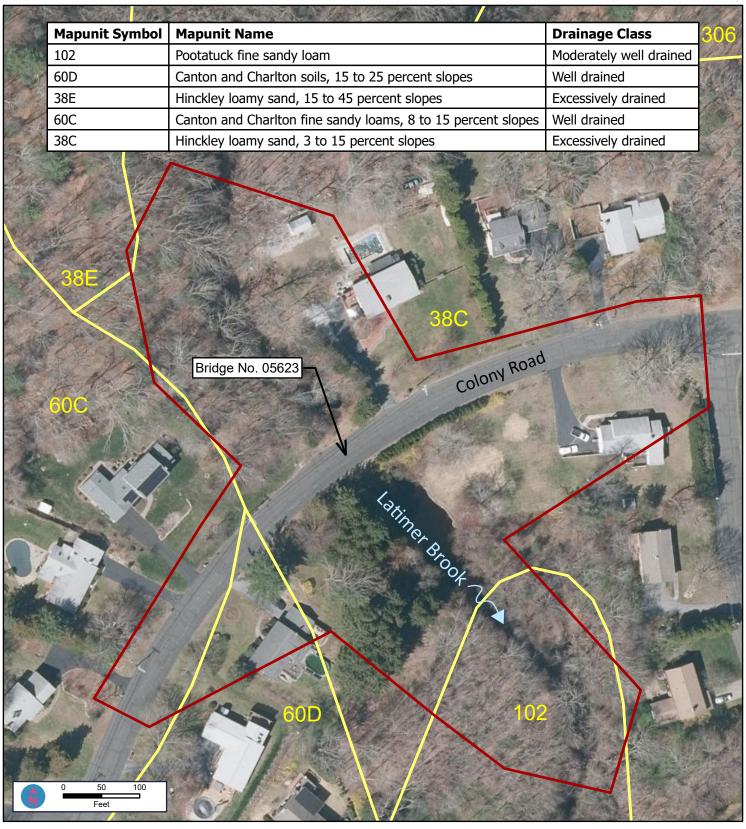
Figure 3 NRCS Soils Map

NRCS soils classifications on the project area are depicted in **Figure 3**, **NRCS Soils Map**. Only those soils found on the project area are described below.

Hinckley gravelly sandy loam, 3 to 5 percent slopes (38C) & Hinckley loamy sand, 3 to 15 percent slopes (38C): The Hinckley series consists of very deep, excessively drained soils formed in glaciofluvial materials. They are nearly level through very steep soils on outwash terraces, outwash plains, outwash deltas, kames, kame terraces, and eskers.

Pootatuck fine sandy loam (102): The Pootatuck series consists of very deep, moderately well drained loamy soils formed in alluvial floodplain material. They are nearly level soils on floodplains subject to frequent to occasional flooding. Slope ranges from 0 to 3 percent.

Rippowam Fine Sandy Loam (103): The Rippowam series consists of very deep, poorly drained loamy soils formed in alluvial sediments. They are nearly level soils on flood plains subject to frequent flooding. Slope ranges from 0 to 3 percent.

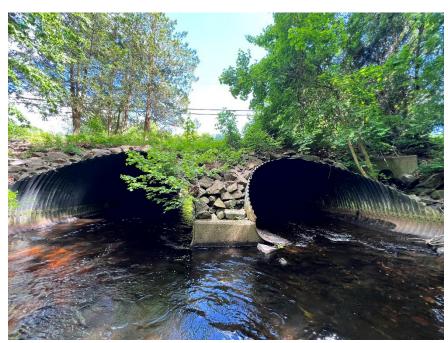
Looking south (downstream) at bridge (May 2024)

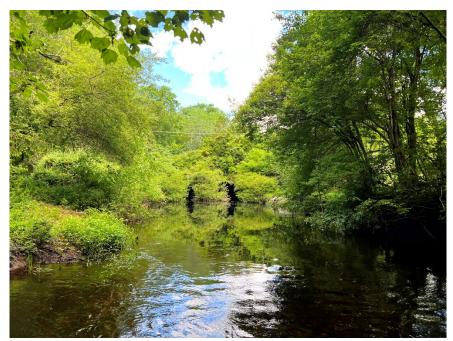
Looking north (upstream) at the bridge (May 2024)

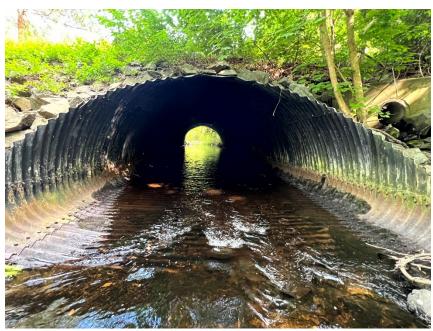
Looking south (downstream) at the bridge (May 2024)

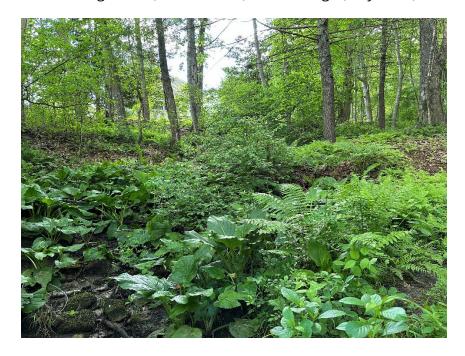
Wetland 1: Wetland 1 is a palustrine forested/emergent wetland (PFO1/PEM1) in the northwest portion of the project area, north of Colony Road. Vegetation in Wetland 1 includes Red Maple (*Acer rubrum*) trees; Multiflora Rose (*Rosa multiflora*) and Japanese Barberry (*Berberis thunbergii*) shrubs; Jewelweed (*Impatiens capensis*) and Skunk Cabbage (*Symplocarpus foetidus*) compose the herbaceous stratum. The soils in Wetland 1 are mapped as Hinckley loamy sand, but are better classified as Rippowam fine sandy loam, 0 to 3 percent slopes. Wetland 1 provides the following functions and values: fish and shellfish habitat and wildlife habitat. Wetland 1 is a state- and federally-regulated wetland.

Looking west at Wetland 1 (May 2024)

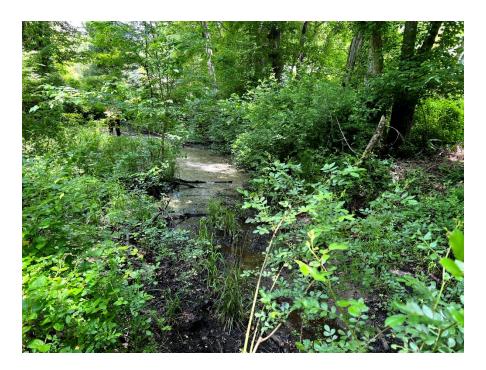
Wetland 2: Wetland 2 is a palustrine forested/emergent wetland (PFO1/PEM1) located on the eastern side of Latimer Brook, south of Colony Road. Vegetation in Wetland 2 includes Red Maple trees, Multiflora Rose shrubs, Poison Ivy (*Toxicodendron radicans*) vines, and Skunk Cabbage in the herbaceous stratum. Wetland 2 receives water from Latimer Brook, which backflows into this wetland. The soils in this wetland were observed to be Rippowam fine sandy loam, 0 to 3 percent slopes. Numerous frogs and tadpoles were observed in Wetland 2; the water is ponded, diffuse, and interspersed with vegetation, providing a breeding habitat for amphibians. The principal functions provided by Wetland 2 are: fish and shellfish habitat and wildlife habitat. Wetland 2 is a state- and federally-regulated wetland.

Looking north at Wetland 2 (May 2024)

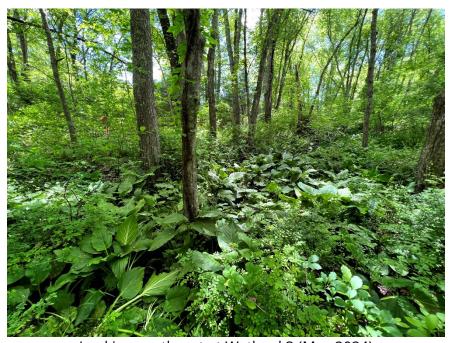
Wetland 3: Wetland 3 is located on the eastern side of Latimer Brook, south of Colony Road and Wetland 2. Wetland 3 is classified as a palustrine forested/emergent wetland (PFO1/PEM1). Vegetation in Wetland 3 includes Red Maple and American Beech (*Fagus sylvatica*) trees; Japanese Barberry, Multiflora Rose, Spicebush (*Lindera benzoin*), and Silky Dogwood (*Cornus amomum*) shrubs; Skunk Cabbage and Sphagnum Moss (*Sphagnum spp.*) in the herbaceous stratum; along with Asiatic Bittersweet (*Celastrus orbiculatus*) and Poison

Looking southeast at Wetland 3 (May 2024)
